# *Duwamish River Floating Wetlands* 2019 Monitoring Report

**Green Futures Lab  
University of Washington**

December 2019

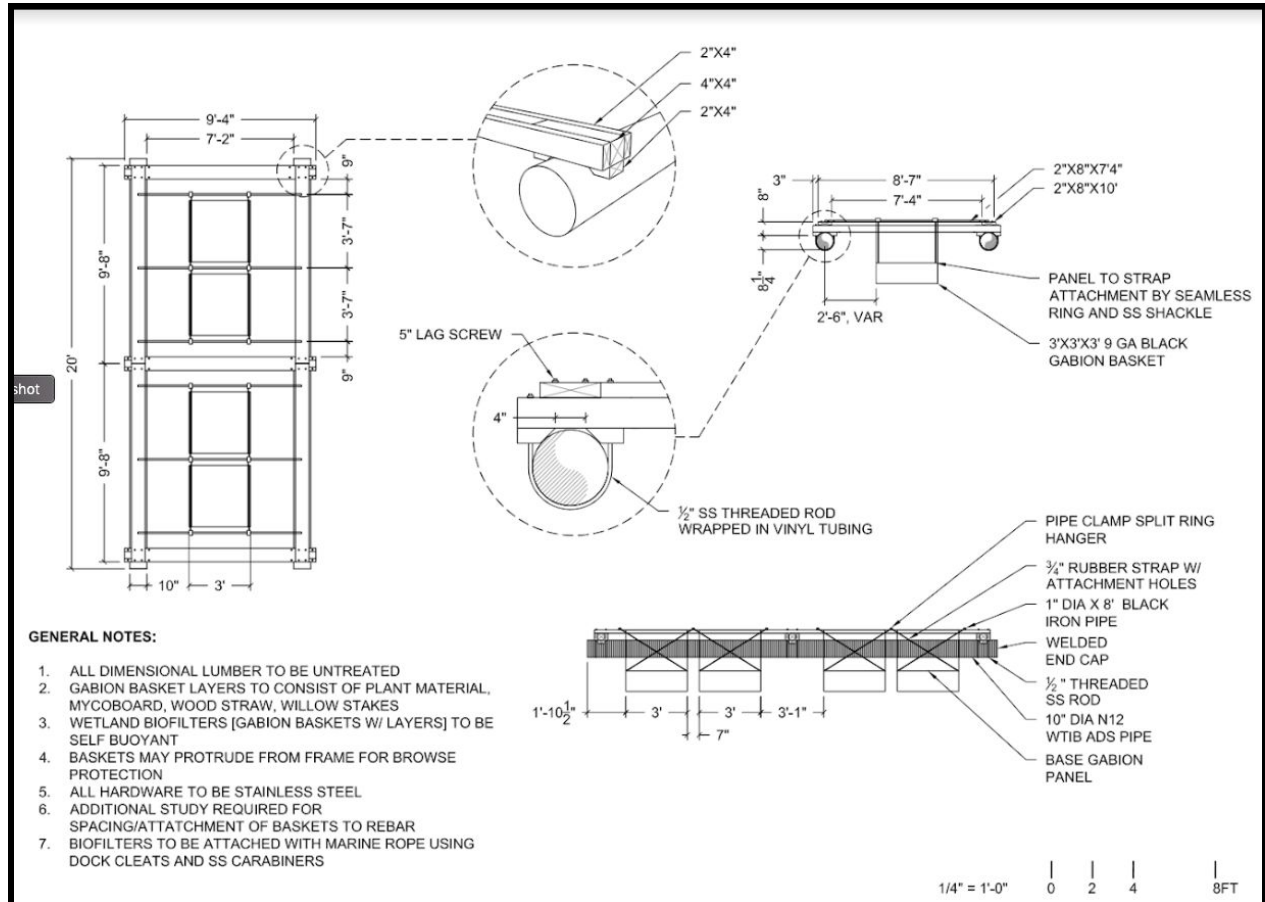
FIGURE 2. BioBarge Design

The BioBarges are capable of supporting four CFW's of approximately 3 feet<sup>3</sup> and weighing approximately 300 lbs each (Figure 2). The CFW's consist of buoyant substrate substrates and native bulrush species protected by gabion baskets. They are designed to support emergent and submergent habitat and have the unique capability of providing underwater habitat. The gabion baskets are fabricated of 0.83-meter (3-foot) untreated 16-gauge wire. The gabion baskets provide a durable envelope that protects plants from browse predation by geese and small mammals, allows for their placement in a variety of settings (e.g. adjacent to stormwater outfalls), and also offer protection from aquatic predators.

a variety of sites. Each BioBarge had four Wetland Biofilters, free-floating within the interior of the BioBarge, and attached to the frame with bungee straps and carabiners.

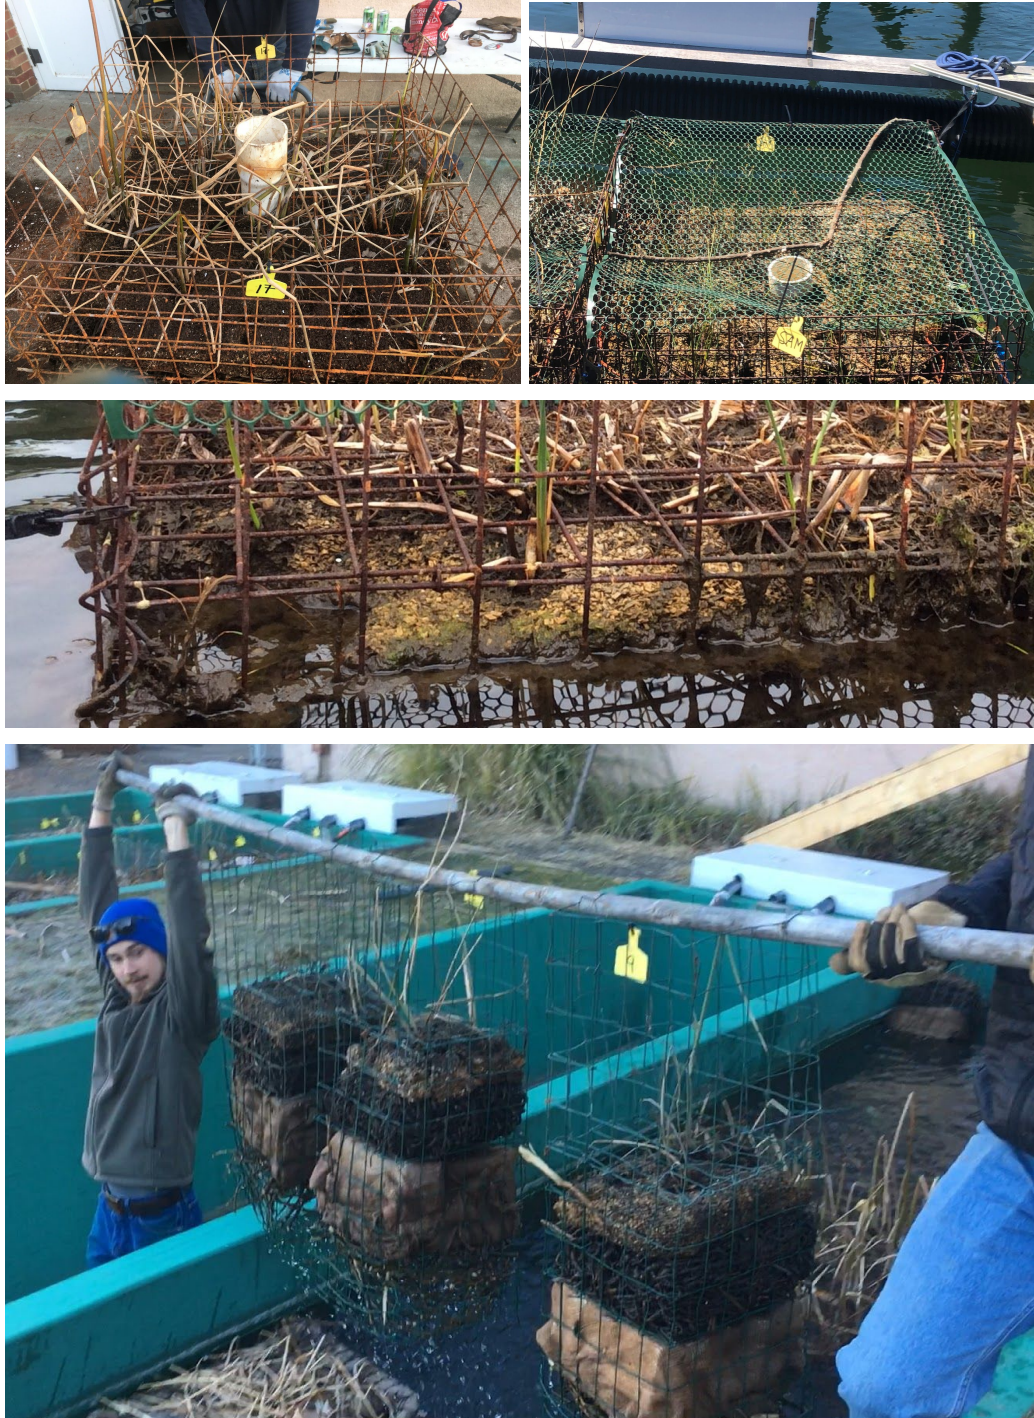
FIGURE 4. Photos of ABS piping in the wetland biofilters (upper left); goose netting on wetland biofilter (upper right); degrading substrate (middle); puck (1' x 1' wetland biofilters) showing the material layers.

Some of the Mycoboard substrates began falling apart early in the monitoring zone. Those that began breaking down early continued to degrade throughout the monitoring period. Those that held strong during the early phase, continued to hold strong to the end. There were two grades of Mycoboard used (A and B), which could explain why some degraded and other didn't.

As the monitoring period stretched on, the mini-biofilter samples, or "pucks," in the BioBarges did not remain upright as initially designed. The pucks were attached to the outside of the Wetland Biofilters between the Wetland Biofilter and the outside edge. Some pucks tipped sideways and lost significant amounts of material in the current.

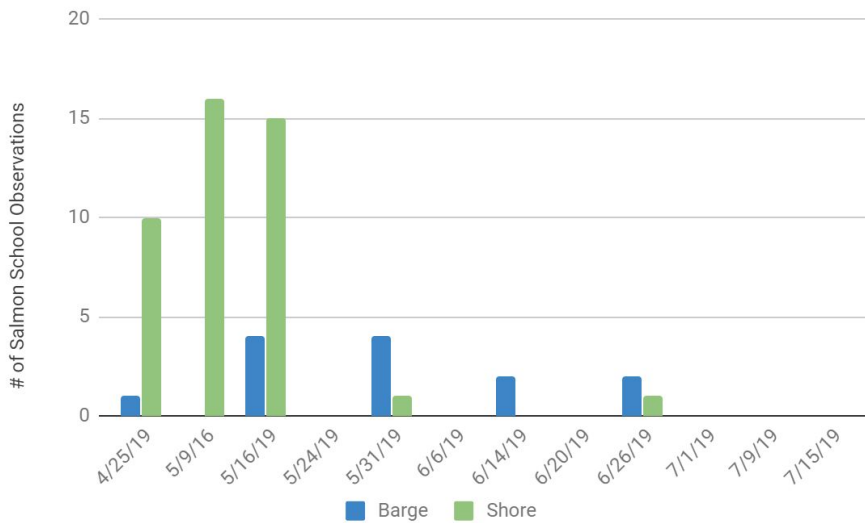
FIGURE 6. Salmon school observations on each monitoring day at T-105.

In this section, we present results from fish monitoring at T-105. Table 3 below summarizes salmon observations for each observing day at both the shoreline reference site and observations of fish from the floating wetland. At T-105, we generally observed more salmon from both the barge and the shoreline earlier in the monitoring season, and were no longer seeing salmon by the end of June at both sites. Chum were predominant in April and early May, and more Chinook than chum were seen by mid-May. Figure 6 below shows the salmon school observation counts as a graph. Observers found it easier in some cases to observe fish from shore because fish were more visible against the bottom than in deeper water. Most observations of schools feeding were made from the shoreline reference site.

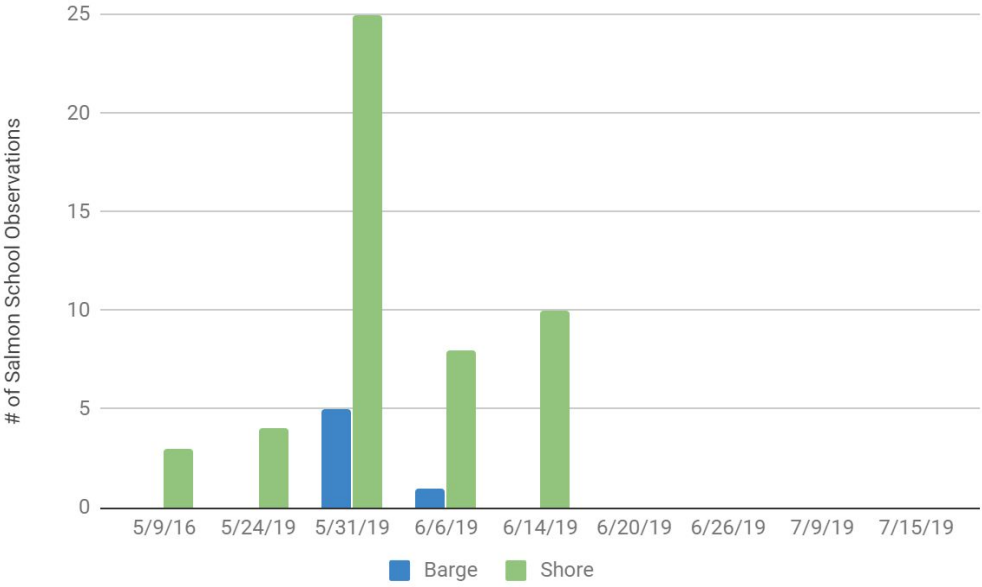
FIGURE 7. Salmon school observations on each monitoring day at T-108.

This section describes results from fish monitoring at T-108. Table 5 below summarizes salmon observations from each day, at the shoreline reference site and from the floating wetland. Similar to T-105, we observed more salmon schools from the shore than from the barge. Visibility from the barge was particularly challenging at T-108, and species identification was more difficult at both the barge and the shore. We did not observe salmon after mid-June at T-108, however several monitoring sessions were cut short due to time constraints towards the end of June. For some of the days where we observed high counts from shore (e.g., 5/31/2019), we found it difficult to differentiate unique schools due to visibility, and may have been observing a large school(s) of fish utilizing the area during the observation window, rather than many unique or separate schools passing through as is recorded. We observed more feeding behavior at the shore than at the BioBarges. Figure 7 below shows only the salmon school observation counts as a graph.

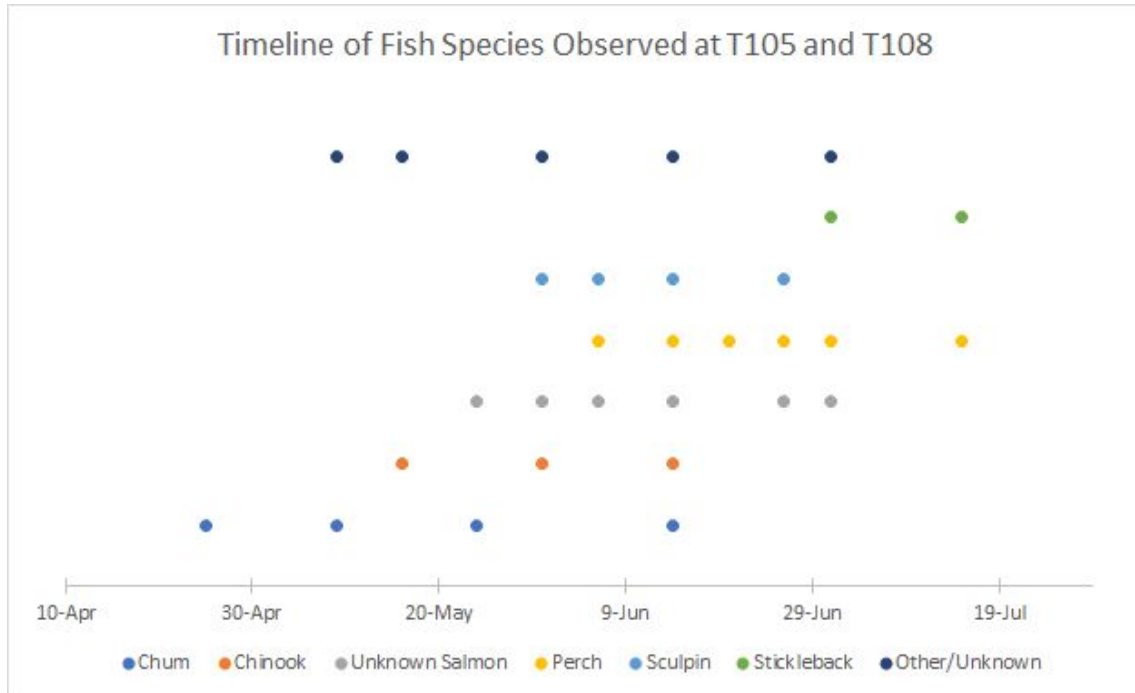
FIGURE 8. Timeline of fish species observed at both locations throughout the monitoring season

In addition to observing salmon utilization of the floating wetlands, we recorded observations of other fish species at the shore and BioBarge structure. Other fish observed included perch, sculpin, and stickleback. Figure 8 below shows how the fish that were observed at each site changed over the course of the monitoring season. Beginning in late May, many more non-salmonid species began to be observed. We observed perch swimming and darting back and forth at depths of 1' to 4' or more, and they often stayed within the general vicinity of the shore and BioBarges during the observation period.

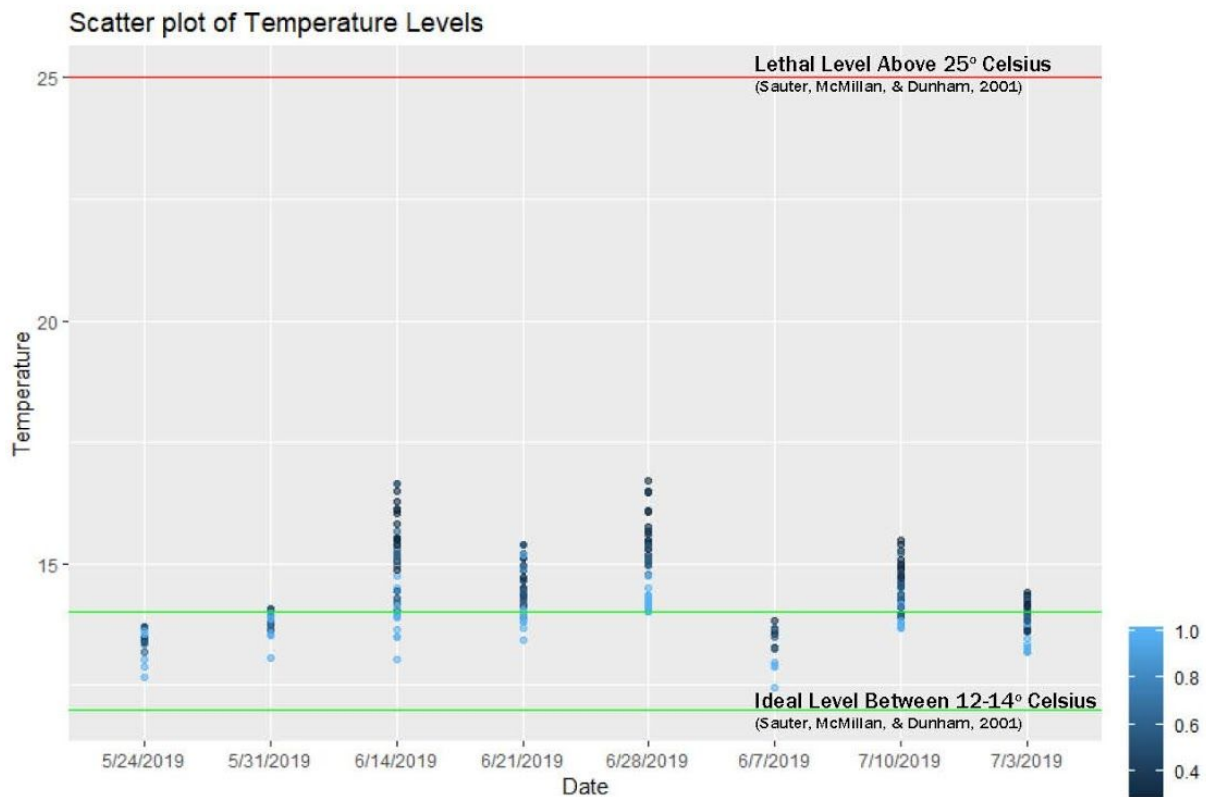
FIGURE 16. Sonde temperature readings with ideal salmon levels in green, lethal salmon levels in red, and the sonde depth (meters) in blue.

Water within the top meter of water column had temperature levels during the study period that ranged between 12.5 and 17°C. Ideal temperature levels for juvenile salmon migration are between 12 and 14°C. Lethal levels for juvenile salmon are above 25°C. The water temperature did not exceed 25°C in the Hobo Pendants™ (Figure 19) and sonde points, shown in Figure 16. There was one spike in the miniDOT data shown in Figure 17, but it is speculated that the data at that point were taken as the miniDOT was being checked at a midway point in the monitoring period. Earlier in the monitoring period, the temperatures appeared to be closer to desired levels of 12 to 14°C. As the monitoring season progressed, the air temperature increased and the cold snow runoff from the mountains decreased creating higher water temperatures, but never in jeopardy of reaching the lethal level.

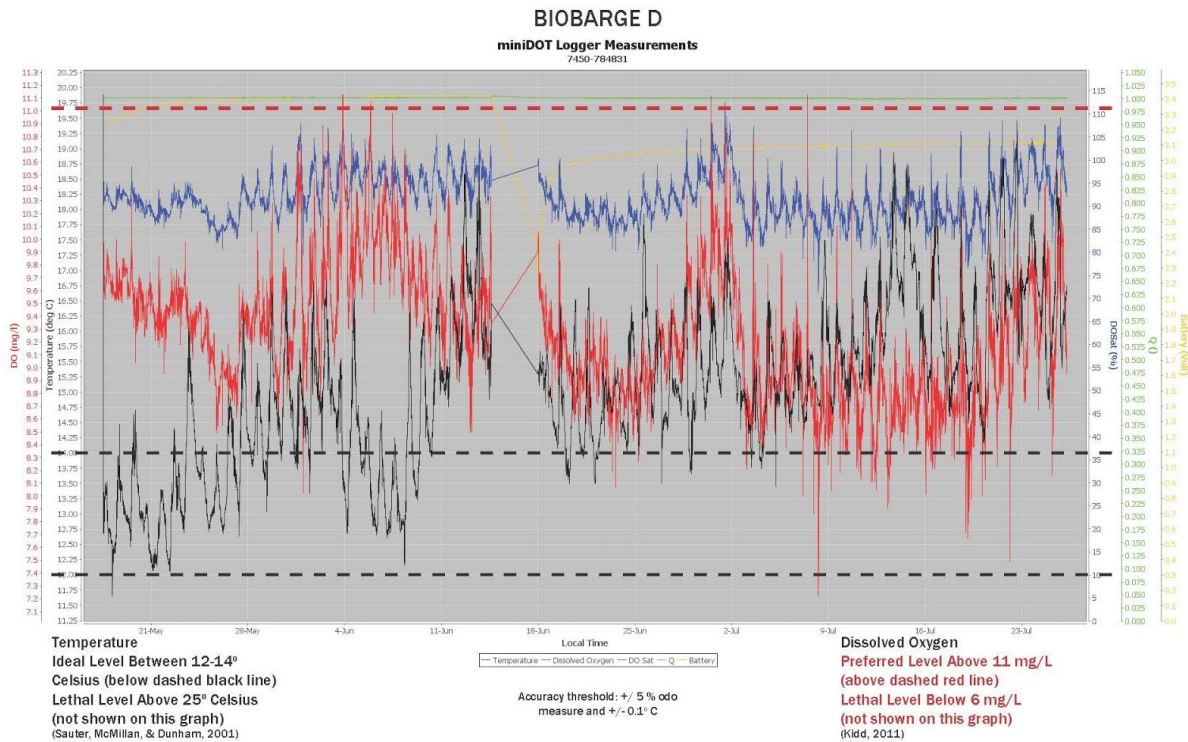
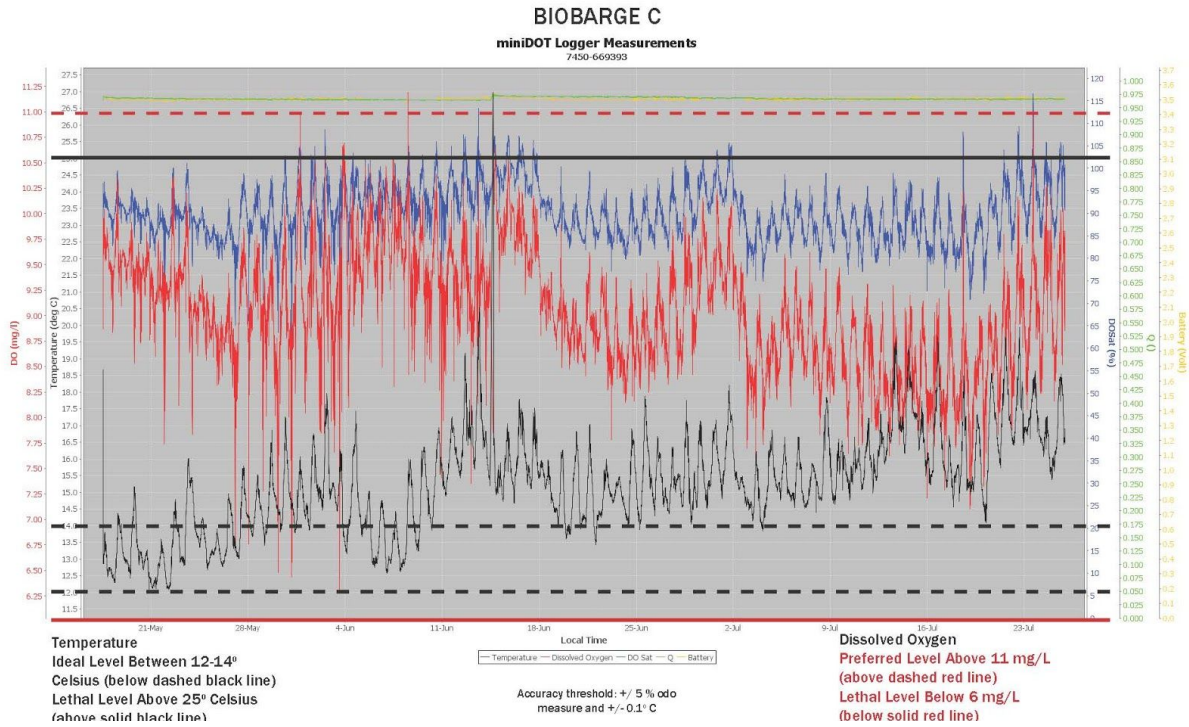
FIGURE 17 Temperature and Dissolved Oxygen Levels from miniDOT Logger, BioBarge C (top) and D (bottom)

Dissolved oxygen levels are preferably above 11 mg/L; salmon can survive in dissolved oxygen conditions that are lower, but less than 6 mg/L can be lethal to juvenile salmon. In the miniDOT readings, the DO levels spiked above the 11 mg/L mark three times (June 4, 8, and July 8) and did not fall below the 6 mg/L mark, seen in Figure 17. Sonde DO levels did not exceed 11 mg/L or fall below 6 mg/L. See Figure 18. The YSI dissolved oxygen measurements exhibited no clear patterns over depth and were similar between T-105 and T-108 biobarges. There was no difference between the BioBarge and the control site at each location. Lastly, the dissolved oxygen patterns measured in the middle of the BioBarge were similar to those measured at the edge of the BioBarge.

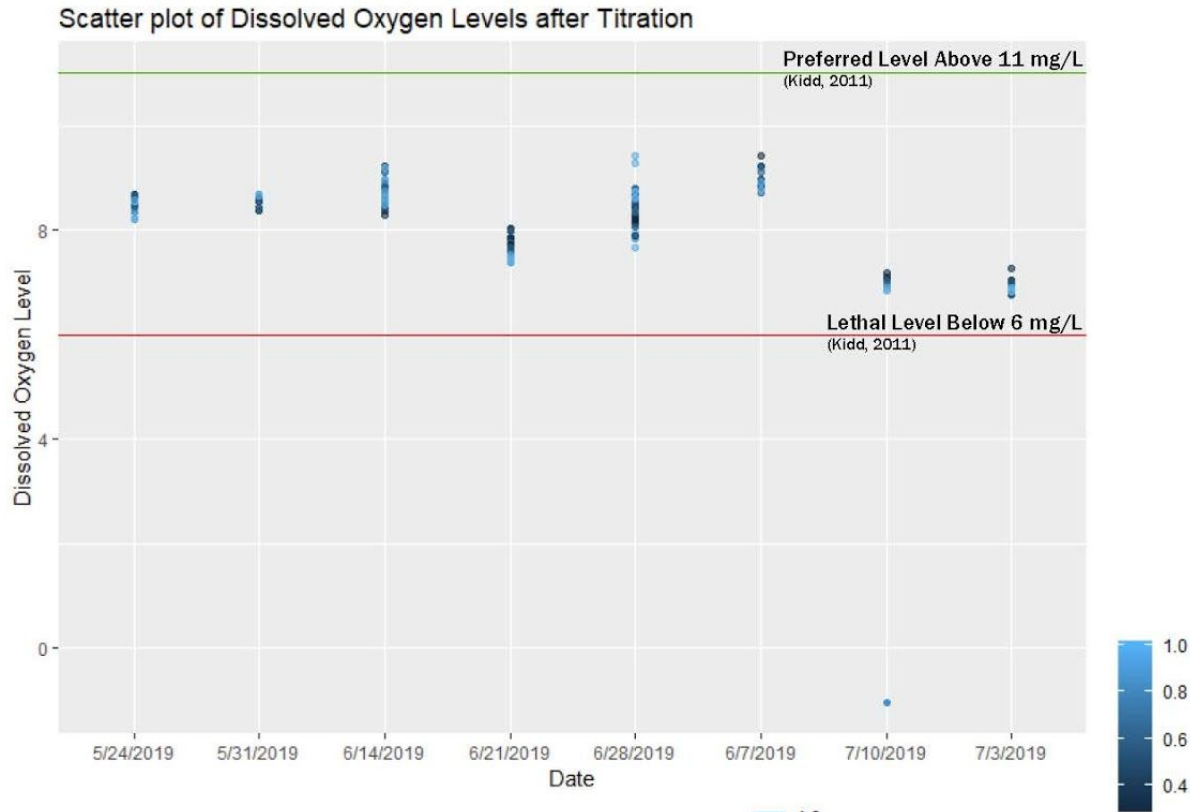
FIGURE 18. Sonde dissolved oxygen readings with preferred levels below green, lethal level below red, and sonde depth (meters) in blue. For Titration information see Appendix C.

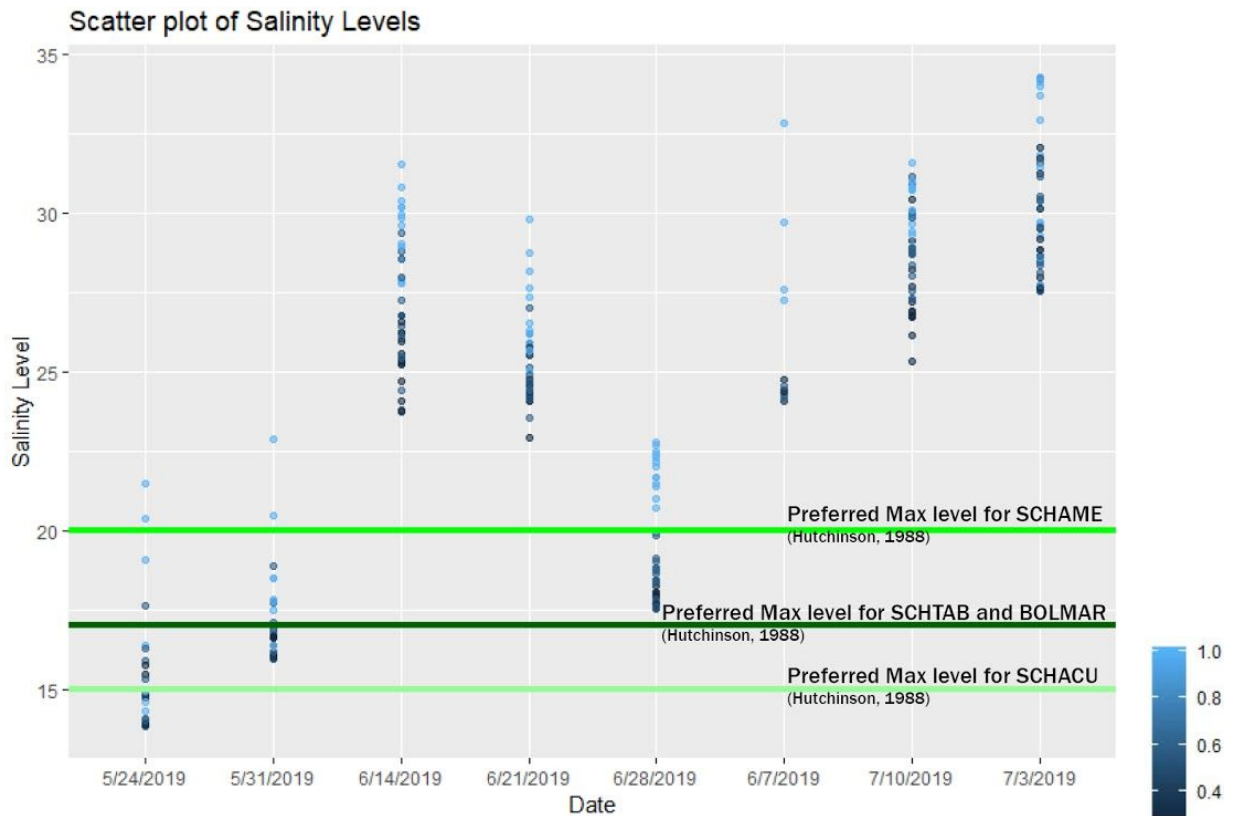
FIGURE 23.Sonde Salinity Levels

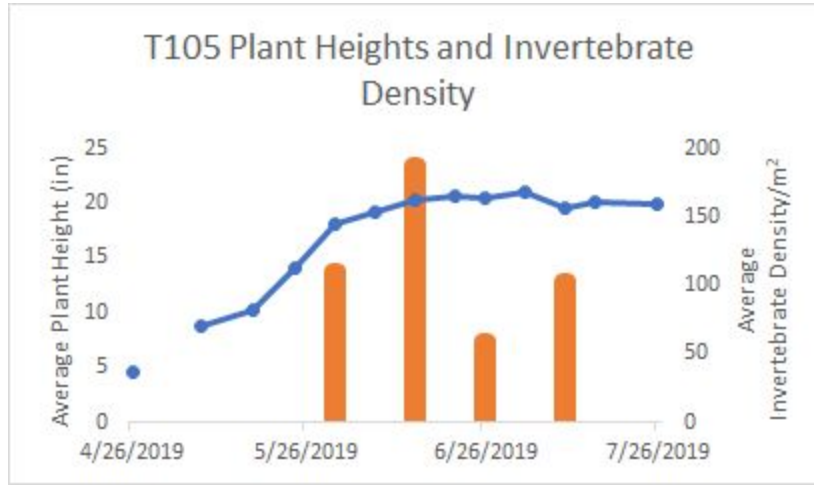
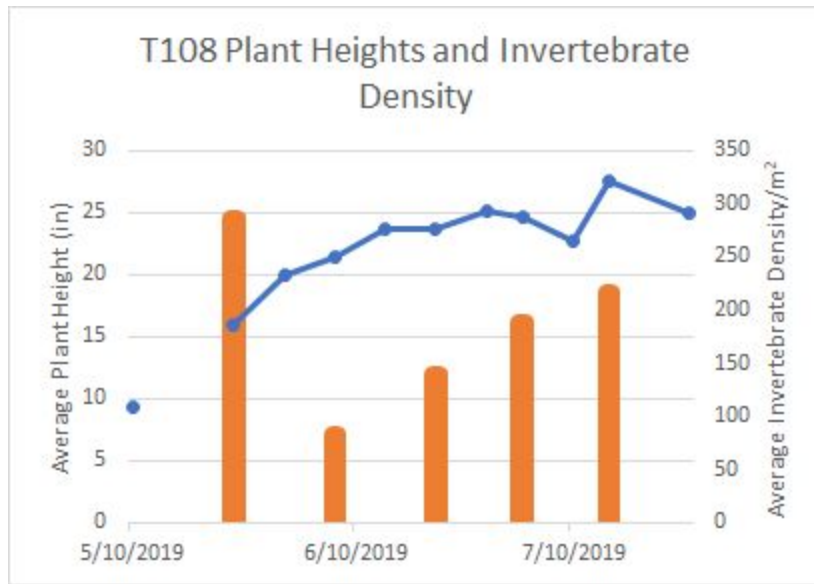
FIGURE 26. Plant heights compared to invertebrate density at T-105 (top) and T-108 (bottom)

In addition to assessing plant growth, we examined any high-level relationships between plant growth and invertebrate density. Figure 26 shows the average plant growth at T-105 and T-108, and average invertebrate density per square meter at the barges. With the exception of a high initial density of invertebrates, invertebrate densities at T-108 increase as average plant height increases. The relationship at T-105 is more variable. This comparison is very rough, averaging plant heights across species may not be representative.

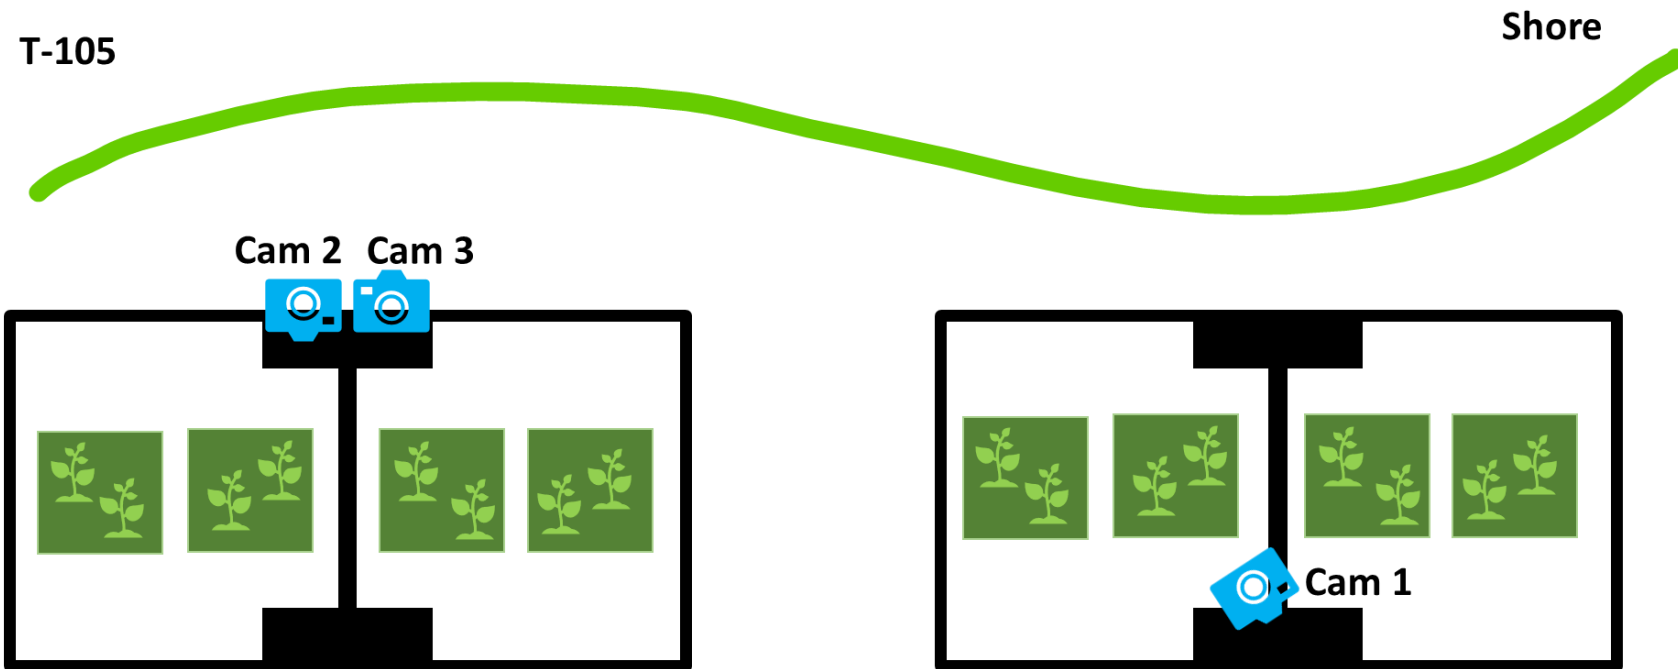
The diagrams below show the configuration of cameras at T-105,

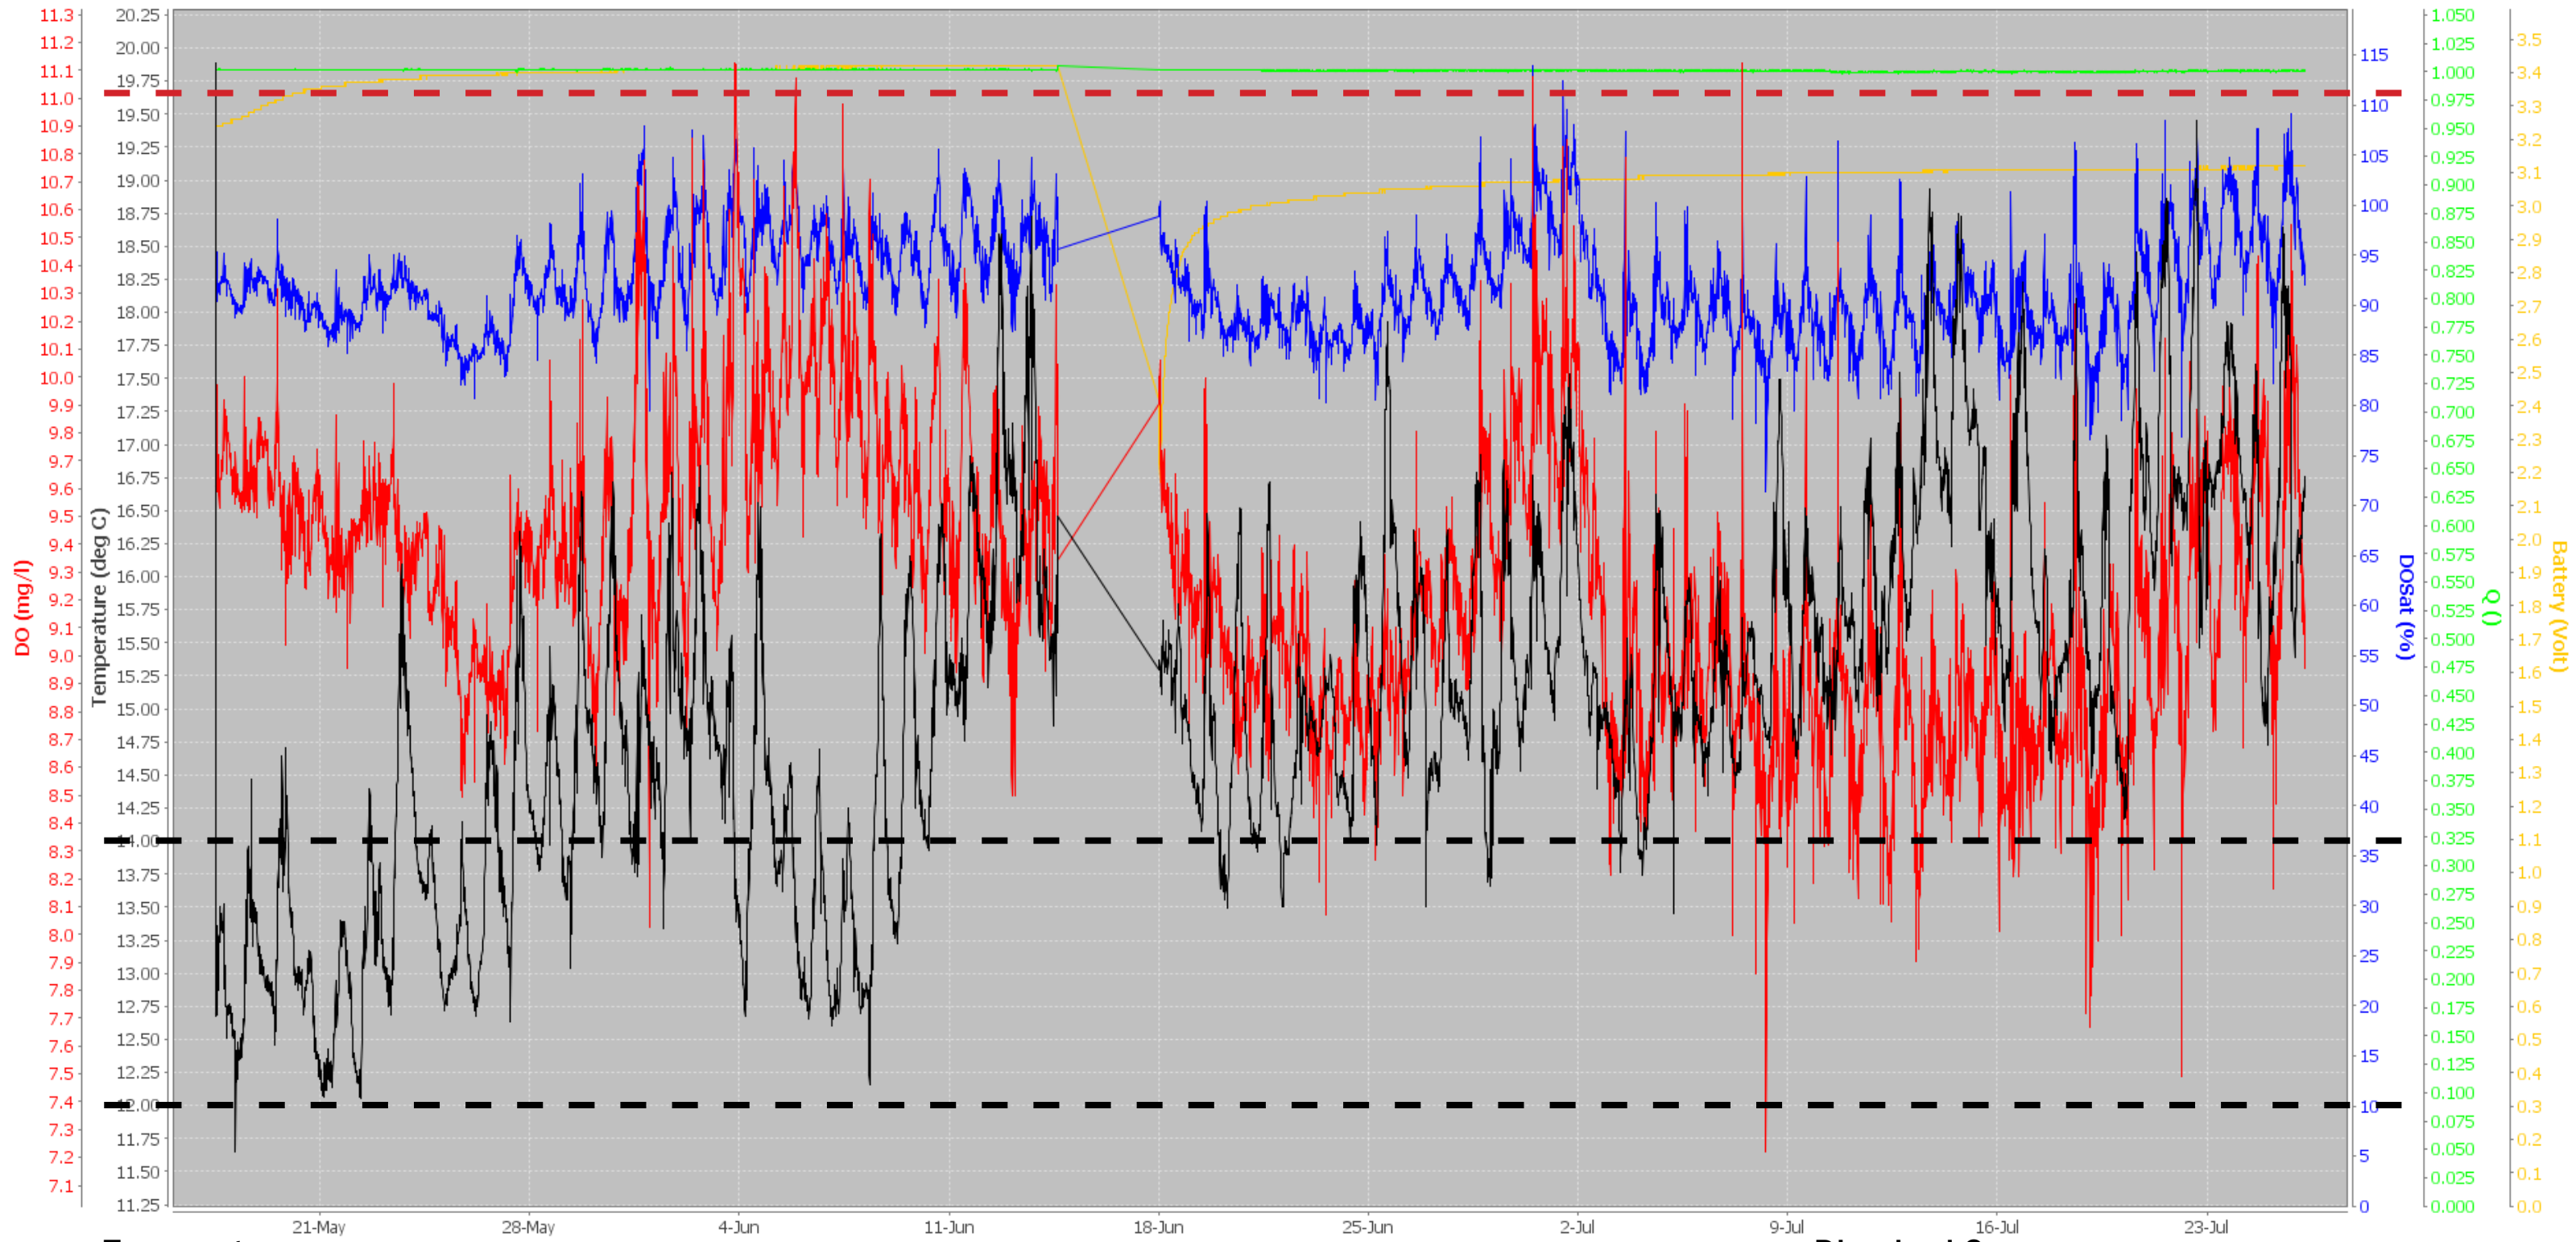
**Temperature**  
**Ideal Level Between 12-14°**  
**Celsius (below dashed black line)**  
**Lethal Level Above 25° Celsius**  
**(not shown on this graph)**  
**(Sauter, McMillan, & Dunham, 2001)**

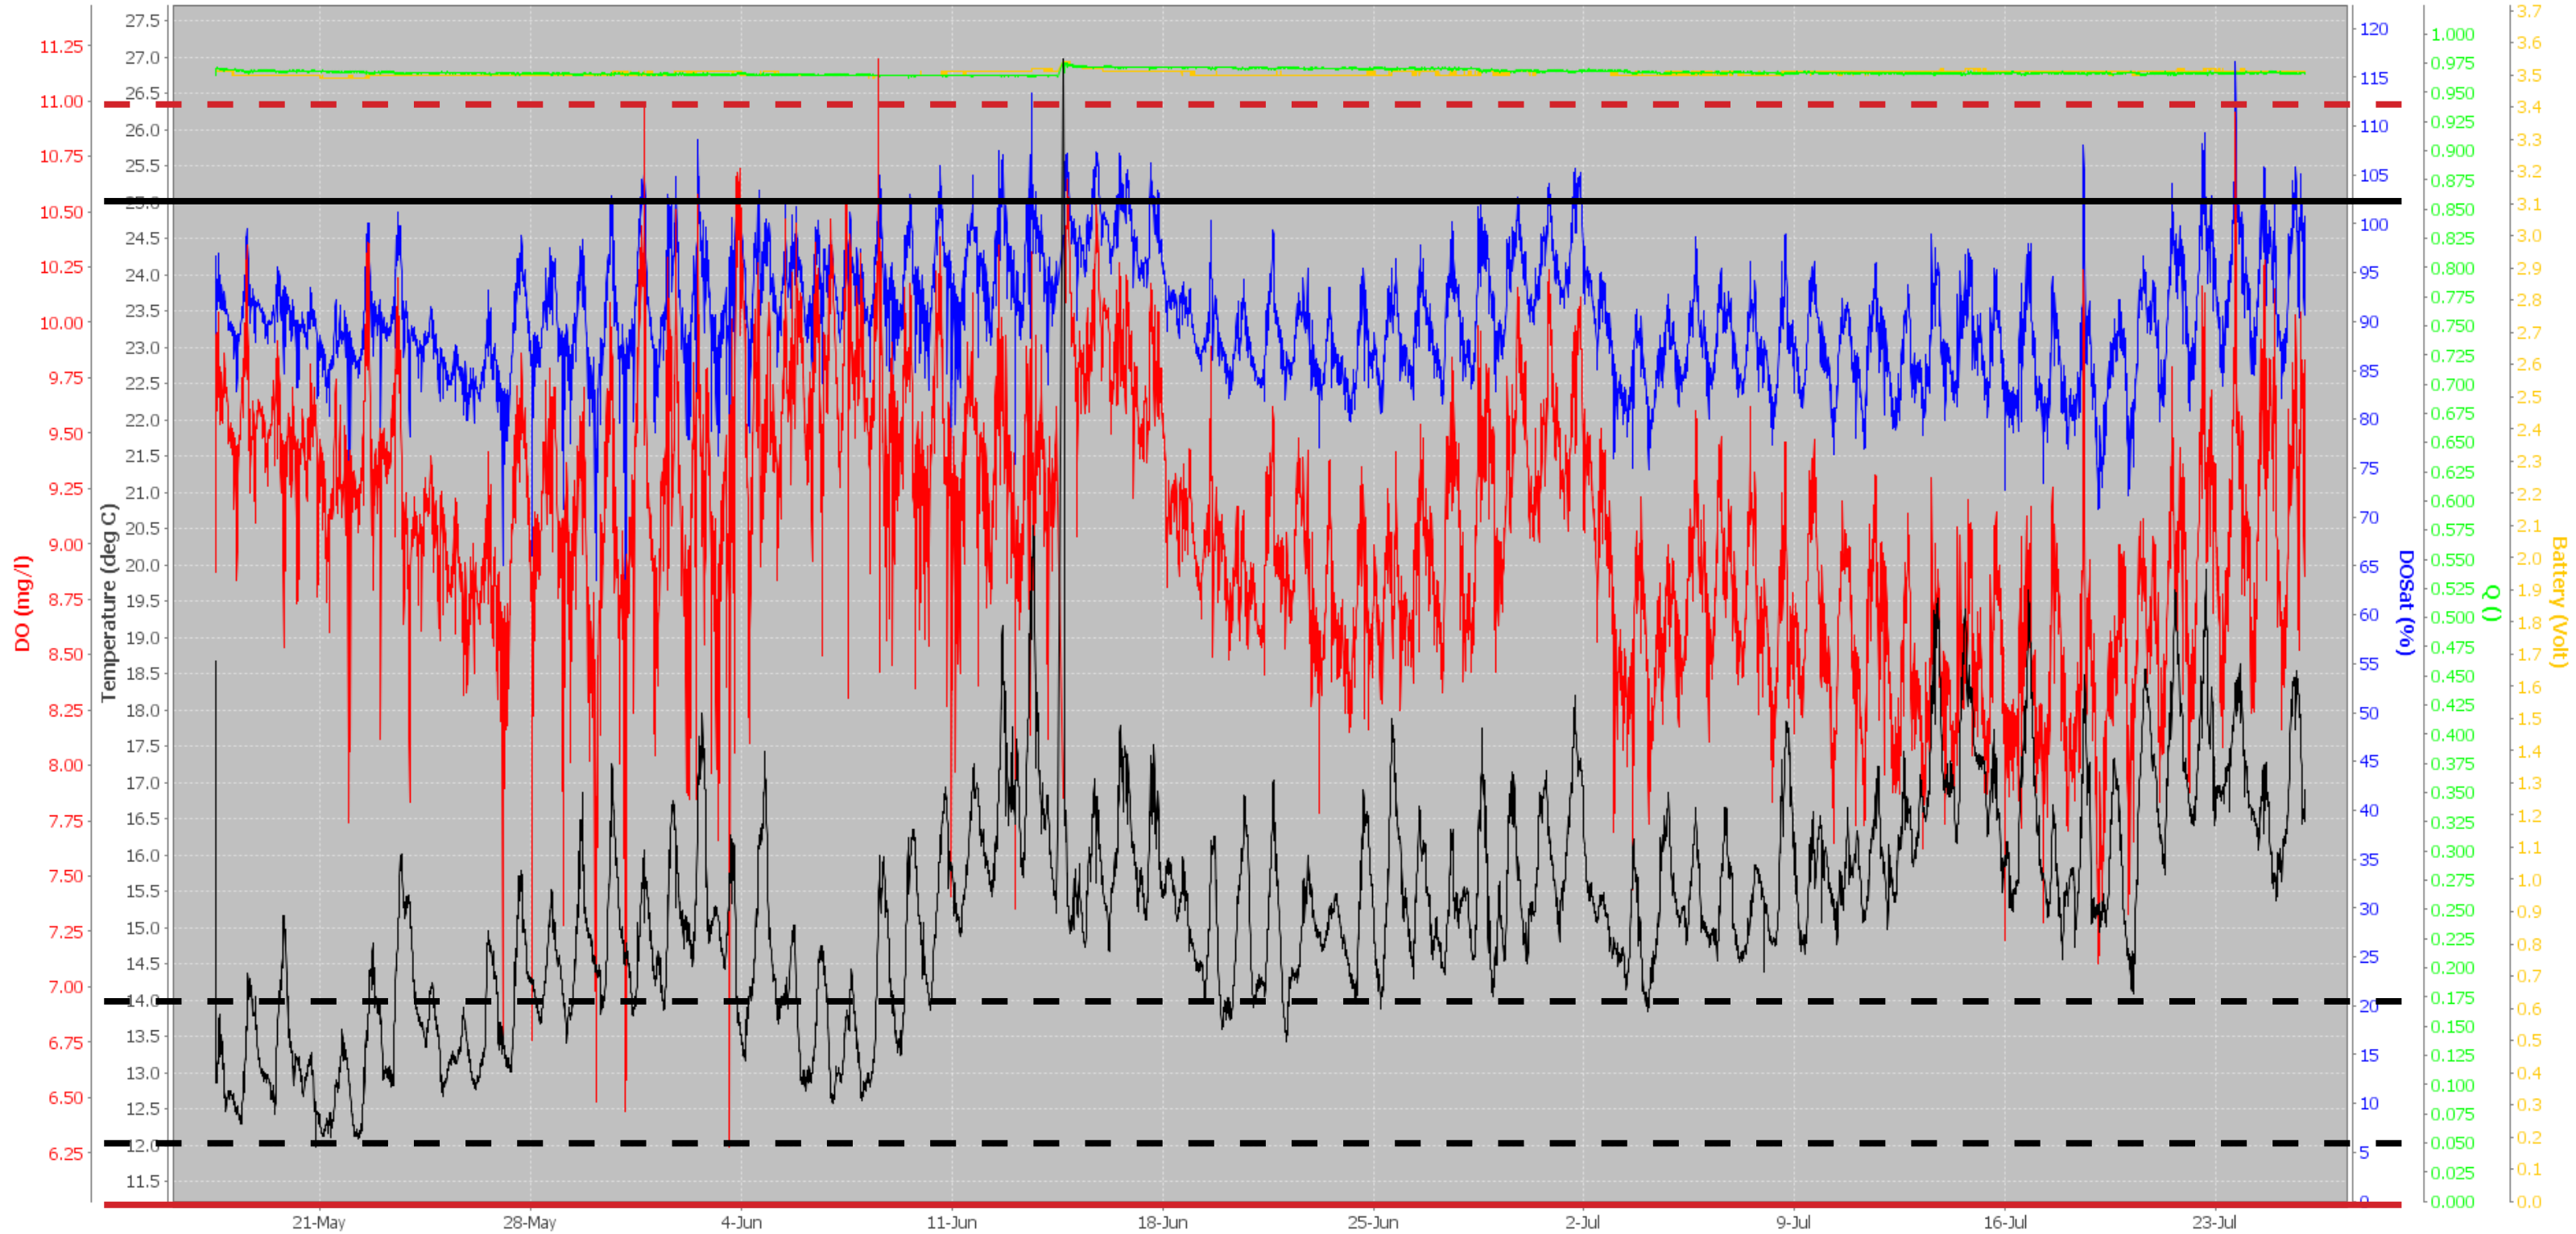
miniDOT Logger Measurements  
7450-669393

**Temperature**  
**Ideal Level Between 12-14°**  
**Celsius (below dashed black line)**  
**Lethal Level Above 25° Celsius**  
**(above solid black line)**  
**(Sauter, McMillan, & Dunham, 2001)**
