Sweetgrass Living Shorelines: 2021 and 2022 Monitoring Report

UW Green Futures Research and Design Lab
College of Built Environments, University of Washington Seattle

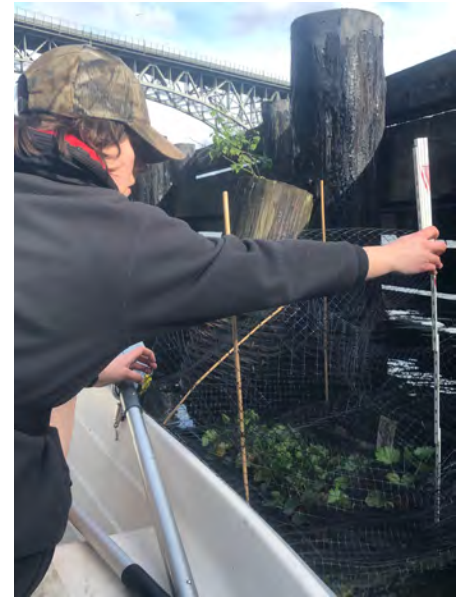
Figure 3.1.2: Community scientist Sloane Palmer demonstrates collecting plant height data at Fremont floating units.

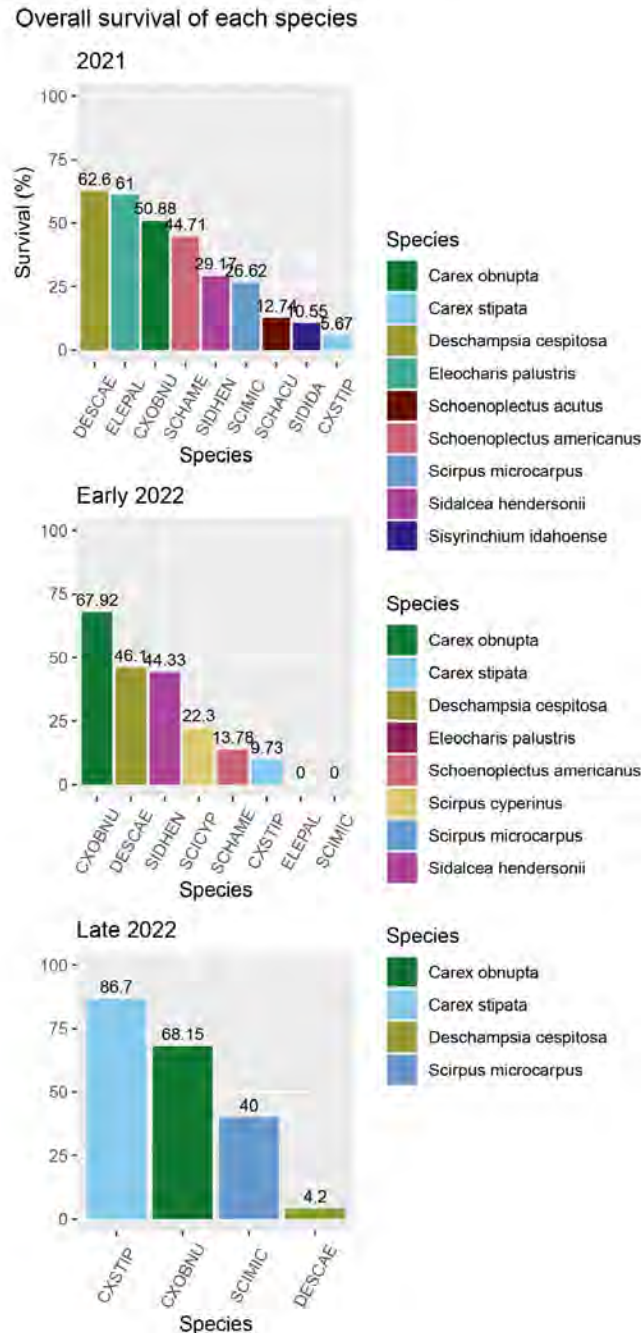
Figure 3.1.4: Figure summarizes the mean percentage of individuals that survived at the end of the data collection for each species at Fremont. Populations were separated by the 2021 sample period, early 2022, and late 2022 after 3 of the units were replanted on 6/24/22. Note that there are two bars for *Carex obnupta* in “Late 2022” because there the species was planted in both a 3.0 model and 4.1 model.

microcarpus, *Carex stipata*, *Eleocharis palustris*, *Schoenoplectus americanus*, and *Sidalcea hendersonii* performed moderately well with survival rates between 90% and 40% but only in one of the collection periods. *Schoenoplectus acutus*, *Scirpus cyperinus*, and *Sisyrinchium idahoense* all had very low or nonexistent survival when at Fremont. These species were also only sampled in one season.

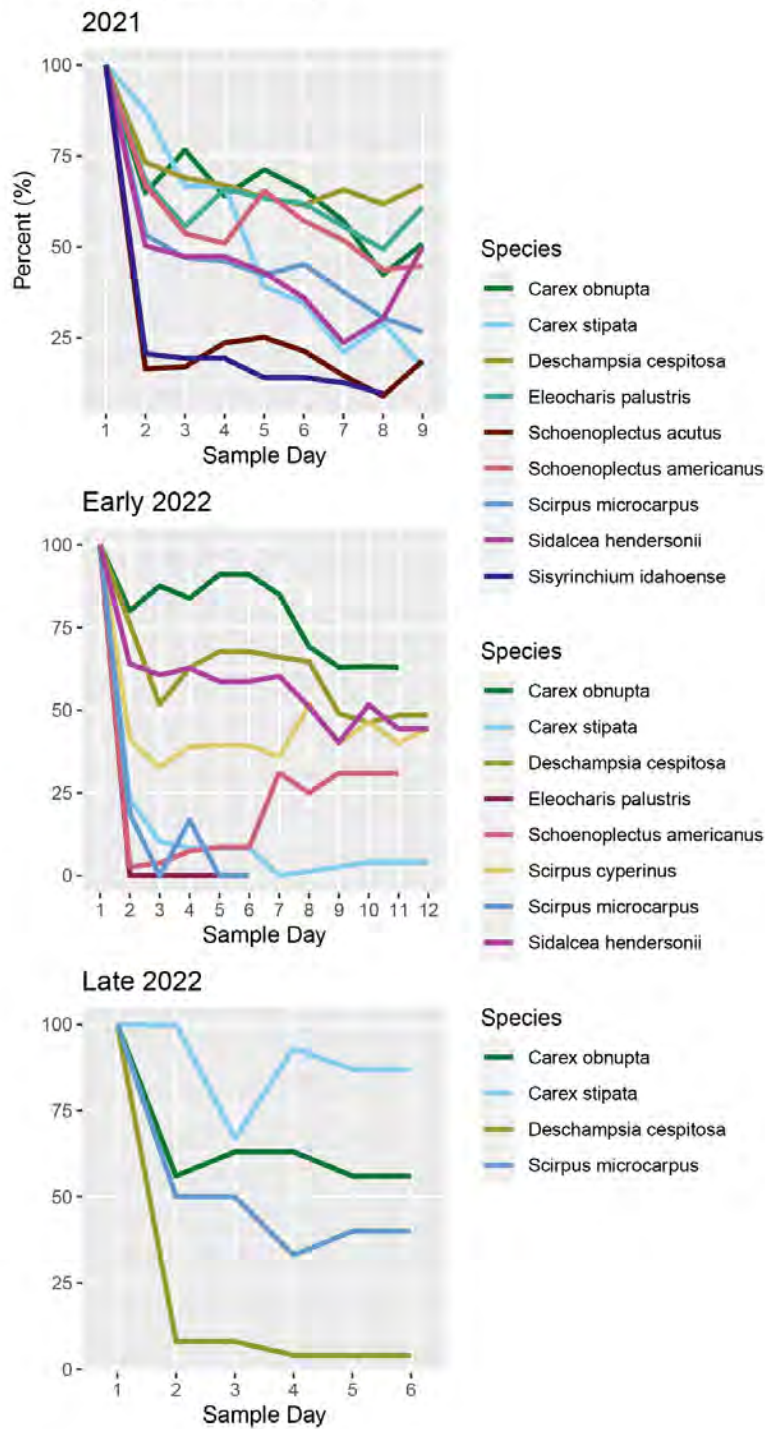
Figure 3.1.5: Figure summarizes the mean percentage of individuals that survived for each species over time at Fremont. Populations were separated by the 2021 sample period, early 2022, and late 2022 after 3 of the units were replanted on 6/24/22.

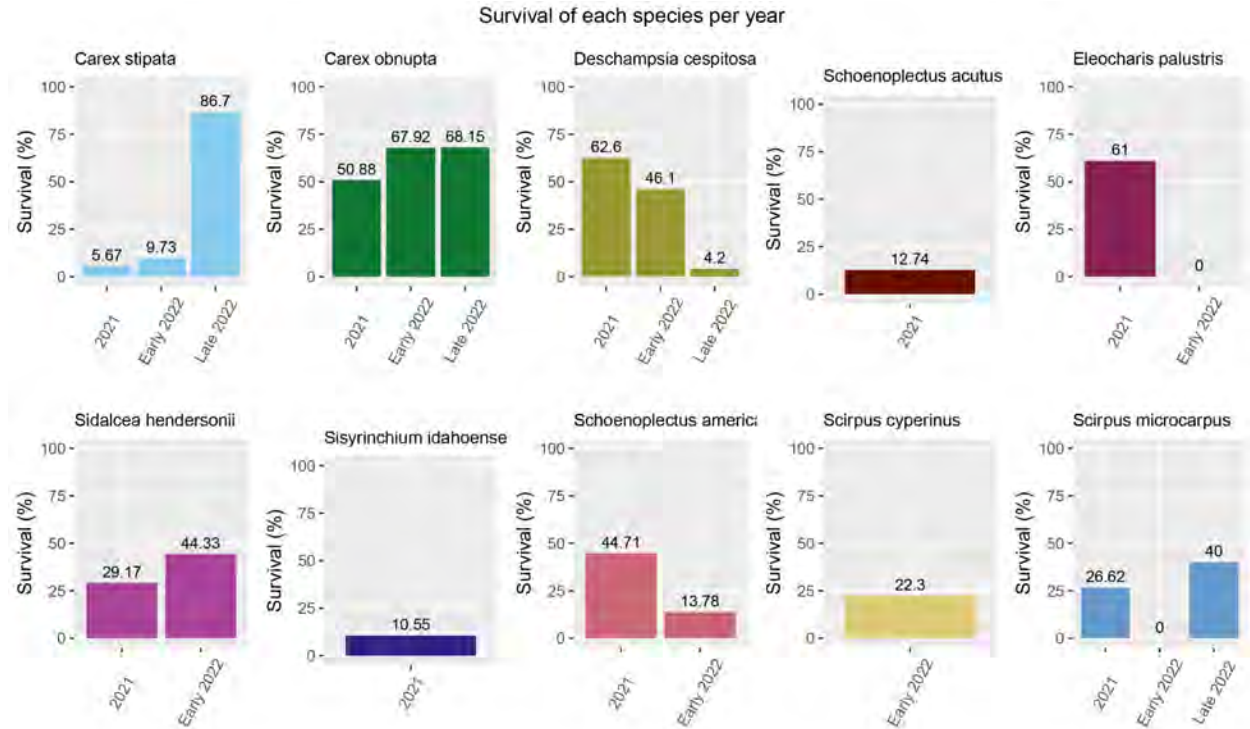
Figure 3.1.6: Figure summarizes the mean of the percentage of individuals that survived at the end of the data collection separated out by each species at Fremont. Populations were separated by the 2021 sample period, early 2022, and late 2022 after 3 of the units were replanted on 6/24/22.

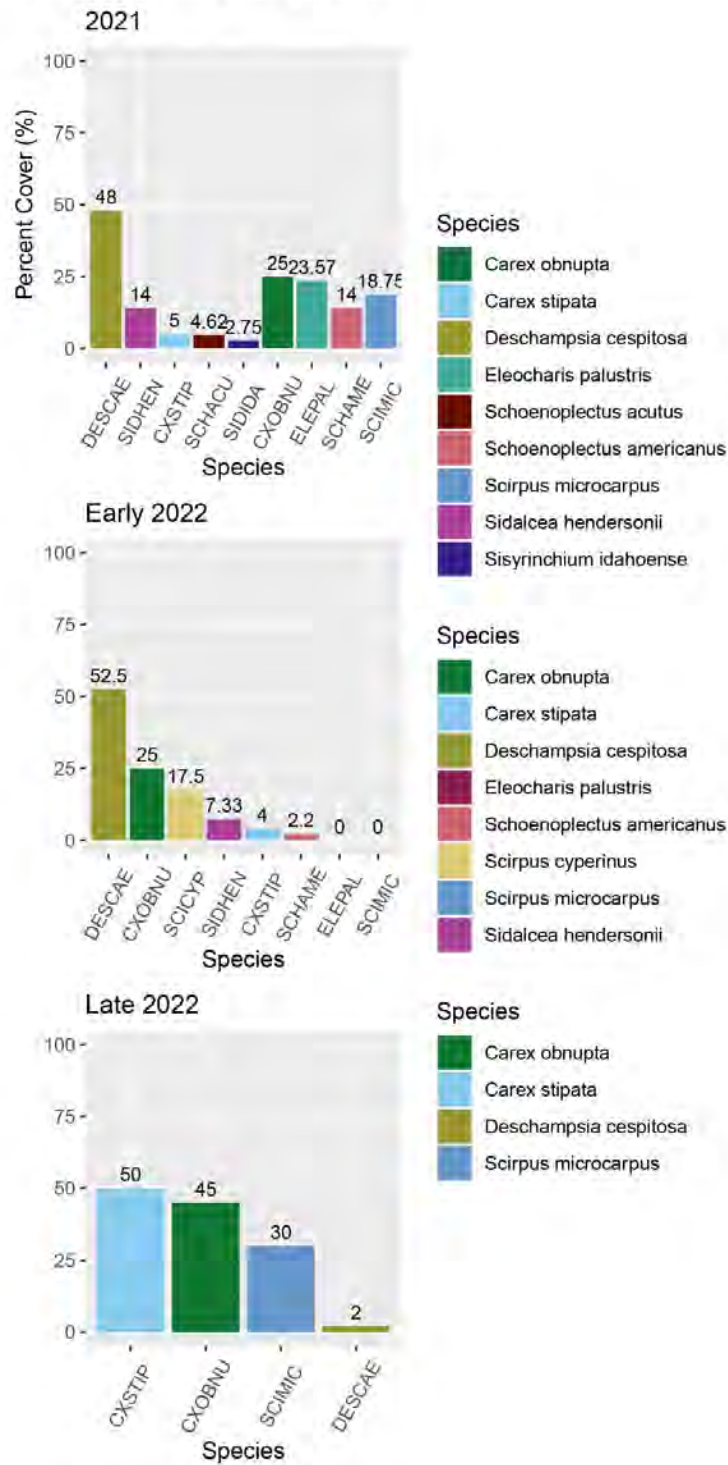
Figure 3.1.7: This figure summarizes the mean of the percent cover of each population at the end of the data collection at Fremont. Populations were separated by the 2021 sample period, early 2022, and late 2022 after 3 of the units were replanted on 6/24/22.

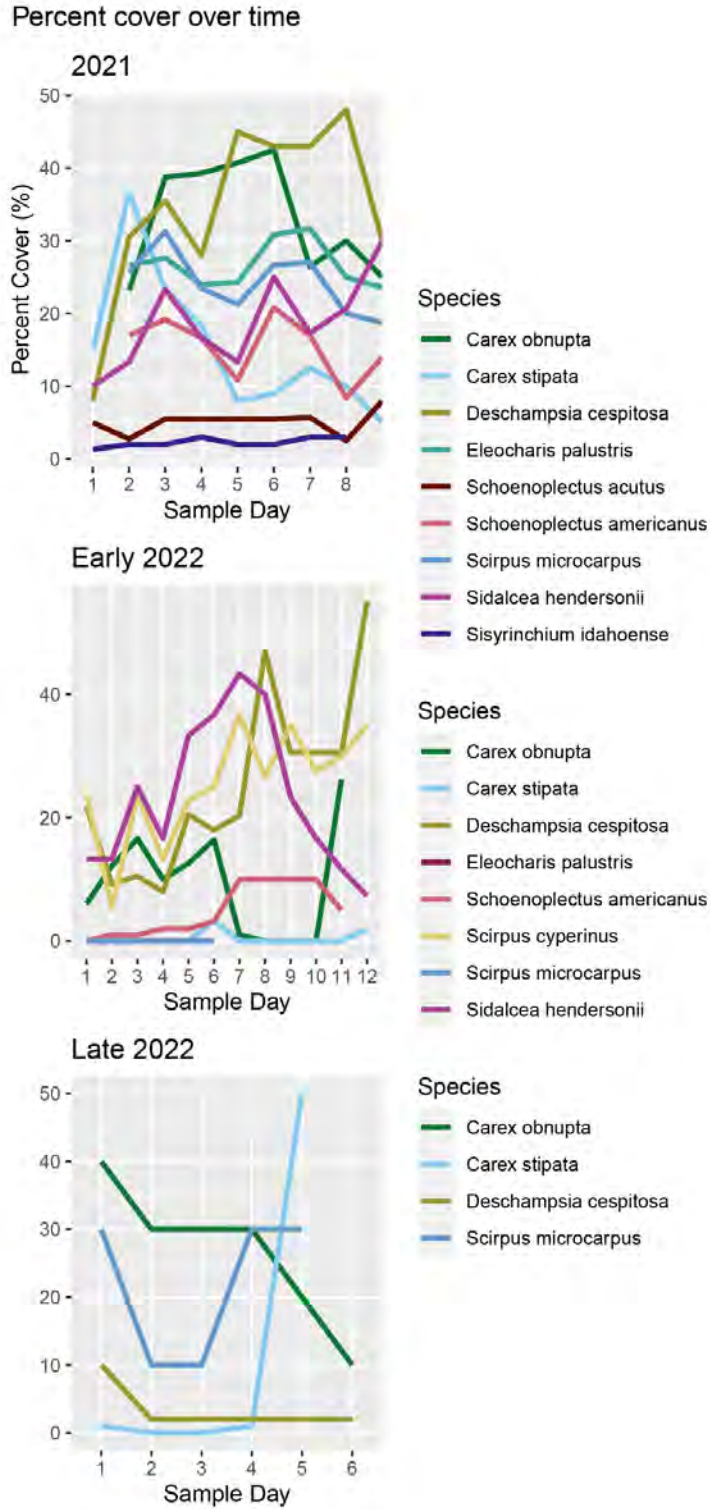
Figure 3.1.8: This figure summarizes the mean of percent cover of vegetation for each species over time at Fremont. Populations were separated by the 2021 sample period, early 2022, and late 2022 after 3 of the units were replanted on 6/24/22.

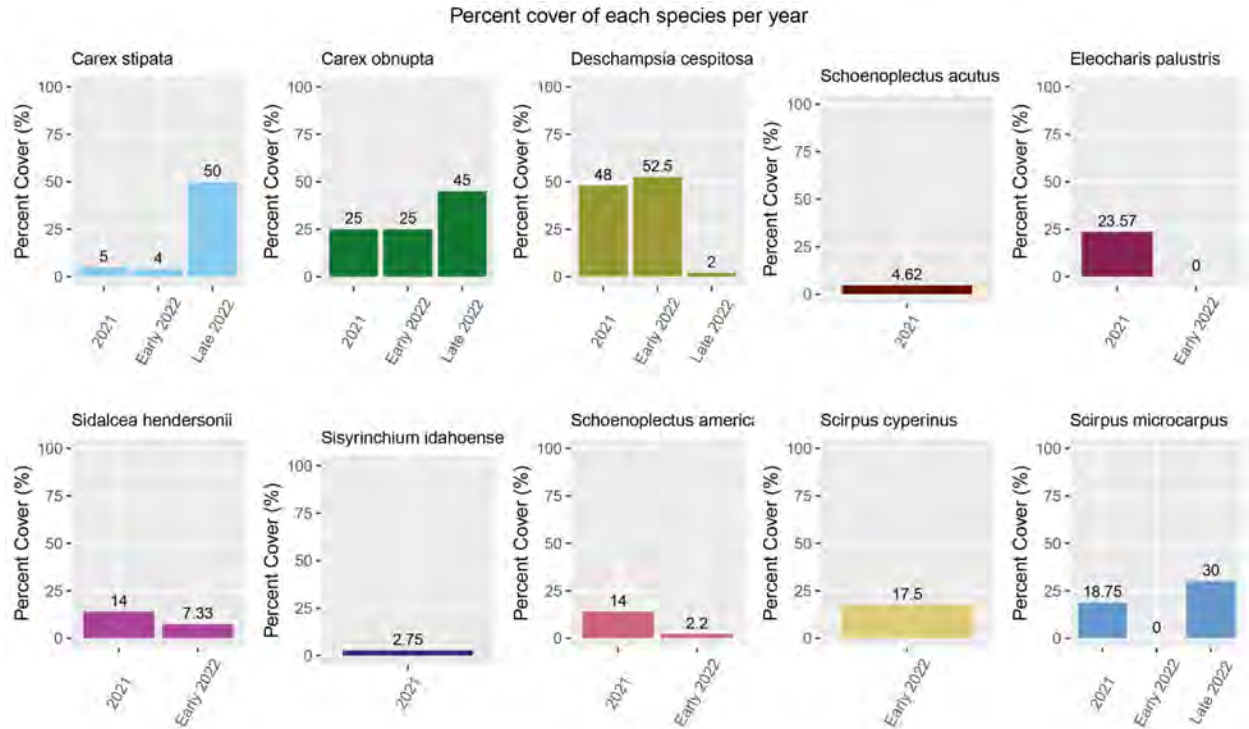
Figure 3.1.9: Figure summarizes the mean of percent cover of vegetation at the end of the data collection separated out by each species at Fremont. Populations were separated by the 2021 sample period, early 2022, and late 2022 after 3 of the units were replanted on 6/24/22.

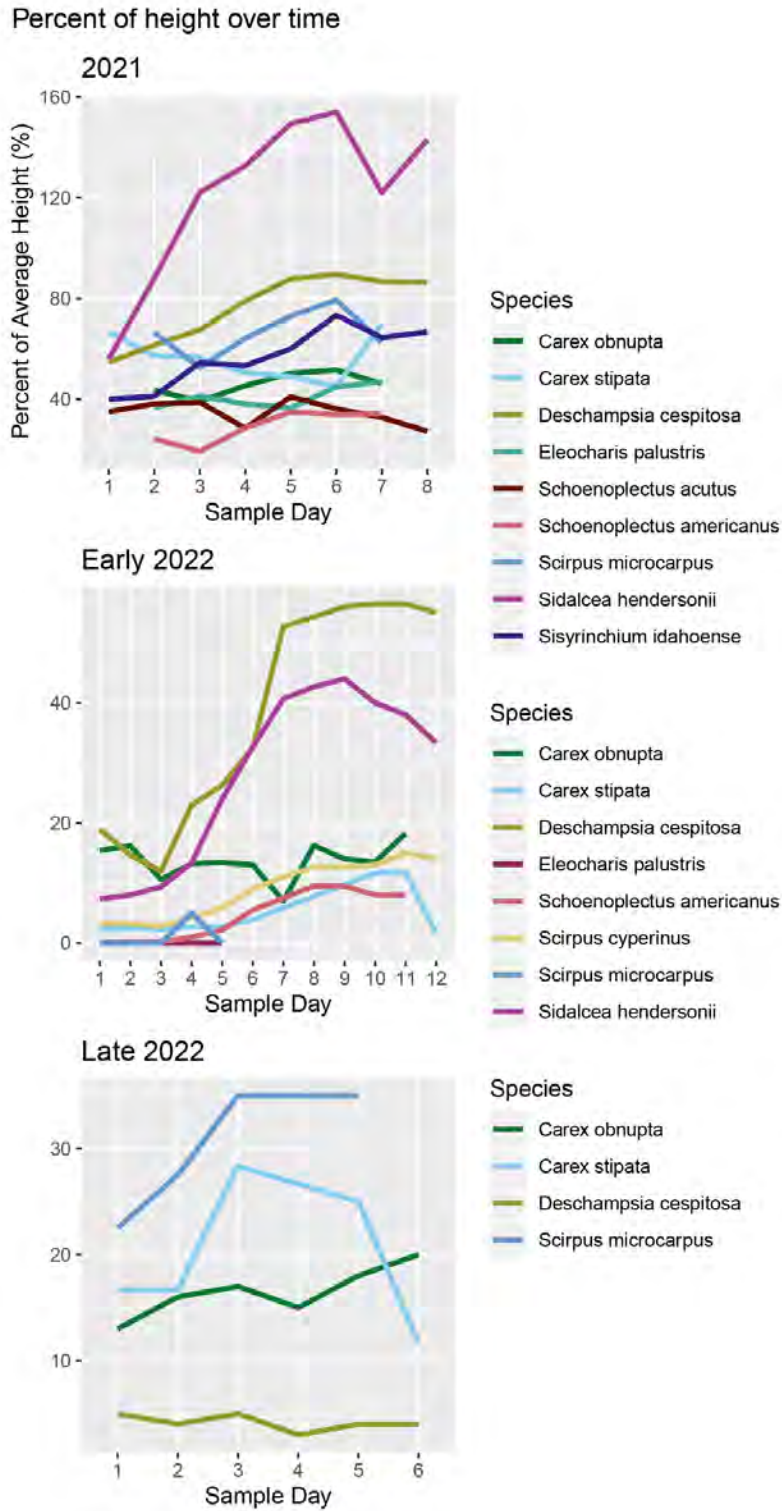
Figure 3.1.11: This figure summarizes the mean of the percentage of height compared to the national average of each species over time at Fremont. Populations were separated by the 2021 sample period, early 2022, and late 2022 after 3 of the units were replanted on 6/24/22.

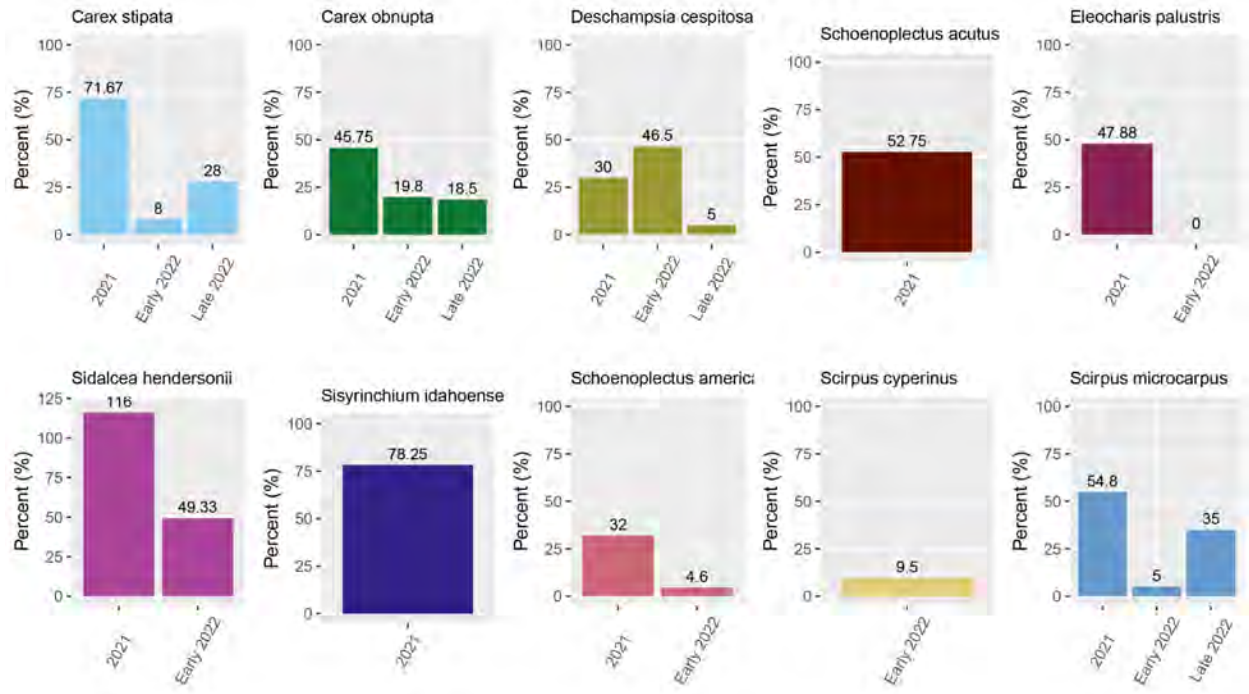
Figure 3.1.12: Figure summarizes the mean of the percentage of height compared to the national average of each species at Fremont. Populations were separated by the 2021 sample period, early 2022, and late 2022 after 3 of the units were replanted on 6/24/22.

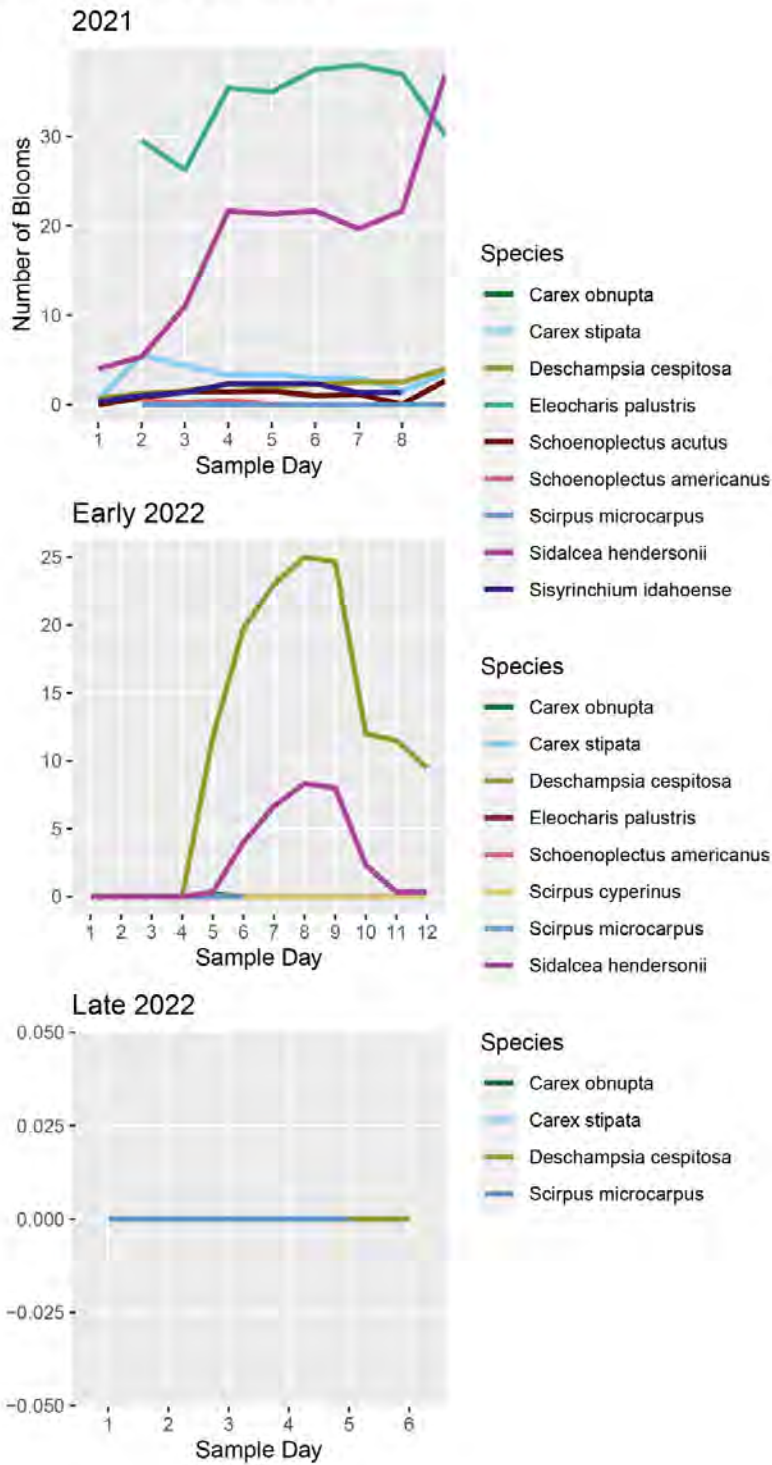
Figure 3.1.14: This figure summarizes the mean number of blooms for each species over time at Fremont. Populations were separated by the 2021 sample period, early 2022, and late 2022 after 3 of the units were replanted on 6/24/22.

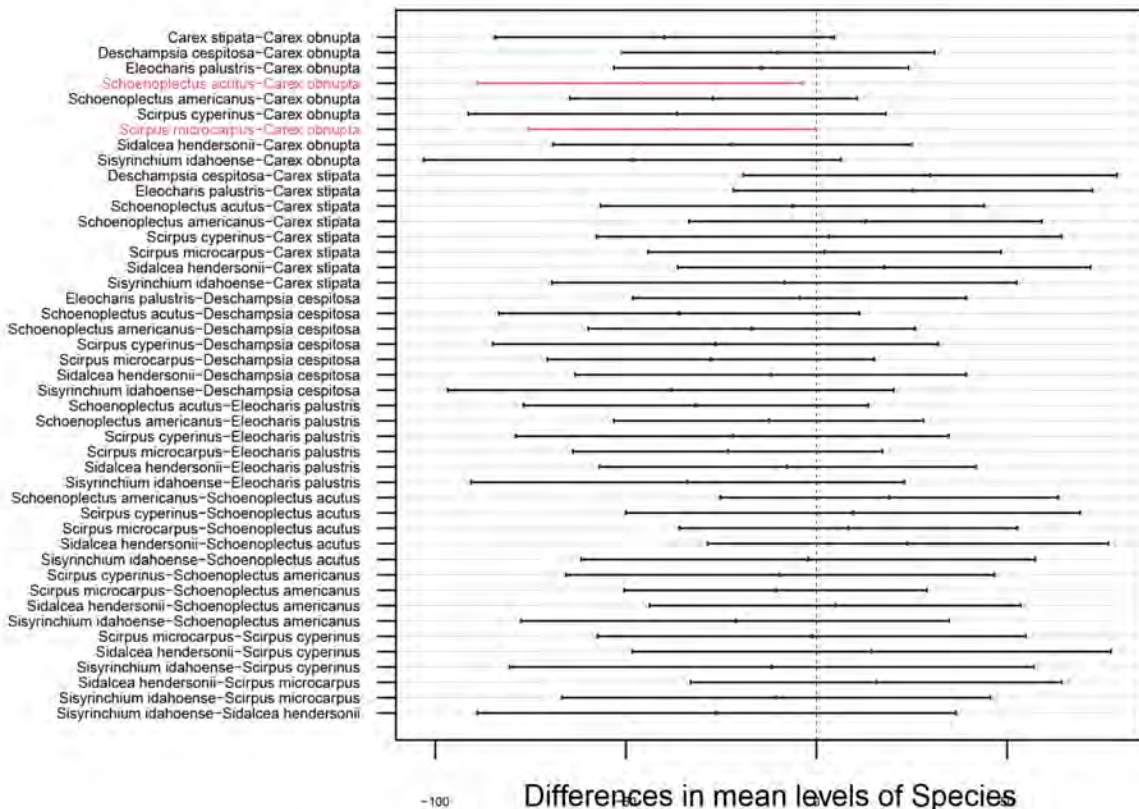
Species	P-Value
All plant species	0.0068

Figure 3.1.15: This figure summarizes the results of the ANOVA test comparing the variance of the mean percentage of survival of each species to overall data at Fremont. The comparisons that fall closer to the centerline have less significant differences. Comparisons that are farther to the left or right have more difference. Species highlighted in red are statistically significant.

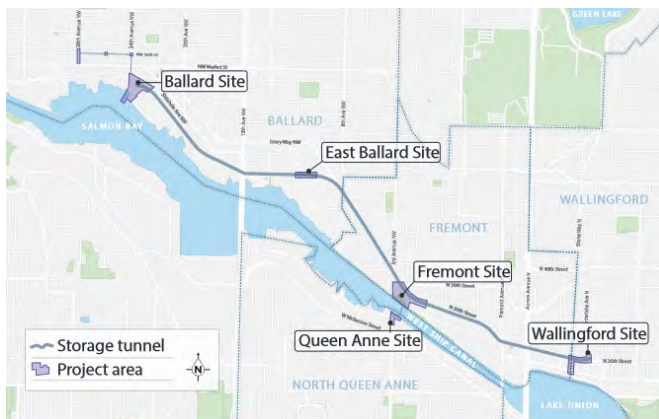
Figure 3.2.1: The project locations of the Ship Canal Water Quality Project. (Image: Seattle Public Utilities and King County)

Seattle Public Utilities and King County Wastewater Treatment Division are leading the [Ship Canal Water Quality Project](#), which includes an underground storage tunnel expected to significantly reduce the amount of polluted stormwater and sewage that flows into the Lake Washington Ship Canal, Salmon Bay, and Lake Union from Seattle's combined sewer system.

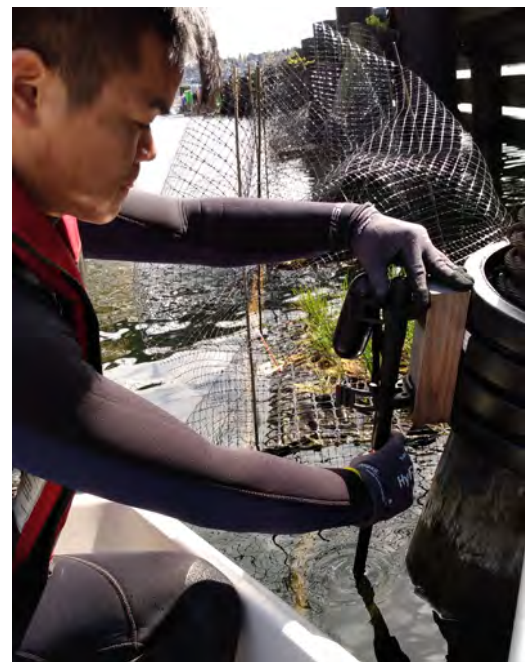
Figure 3.3.1: Adam Nguyen deploys a Go Pro camera connected to a selfie-stick beneath a floating wetland. (Photo: George Thomas Jr.)

The team deployed 5 GoPro video cameras weekly under one floating wetland at each site for 1 hour intervals from May 27th 2021 to July 27th 2022. The experimental cameras were deployed on the end of a selfie stick, attached to a mount on the fender wall, extending approximately 1 foot below water pointing perpendicular to the unit and facing upstream.

The control cameras were deployed on the end of a selfie stick, attached to a mount secured on the fender wall, extending approximately 1 foot below water pointing upstream. During the hour of footage collection, a GoPro camera was suspended from a rowboat and pointed along the shoreline. The footage was reviewed at a later point in time for fish presence and behavior. In the second year of research, a GoPro was attached to a Sonde Water Sensor and lowered to the bottom of the channel in order to determine fish presence at an additional reference point. Cameras were also deployed to capture fish activity during four snorkel sampling events in 2021 and 2022.

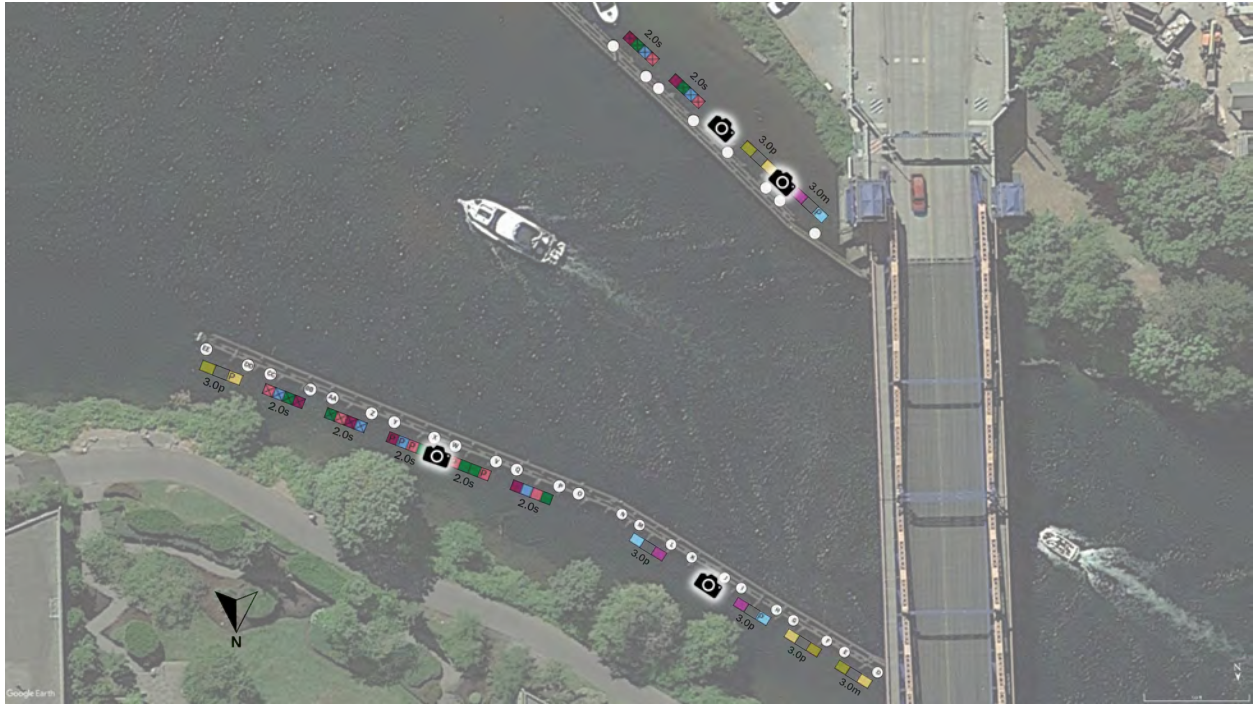
Figure 3.3.2: Shows the locations of the cameras deployed at Fremont. There were 4 cameras attached at the fender wall, 2 control and 2 at units. Another camera was attached to the Sonde and suspended to the bottom of the channel and also moved along the shorelines.

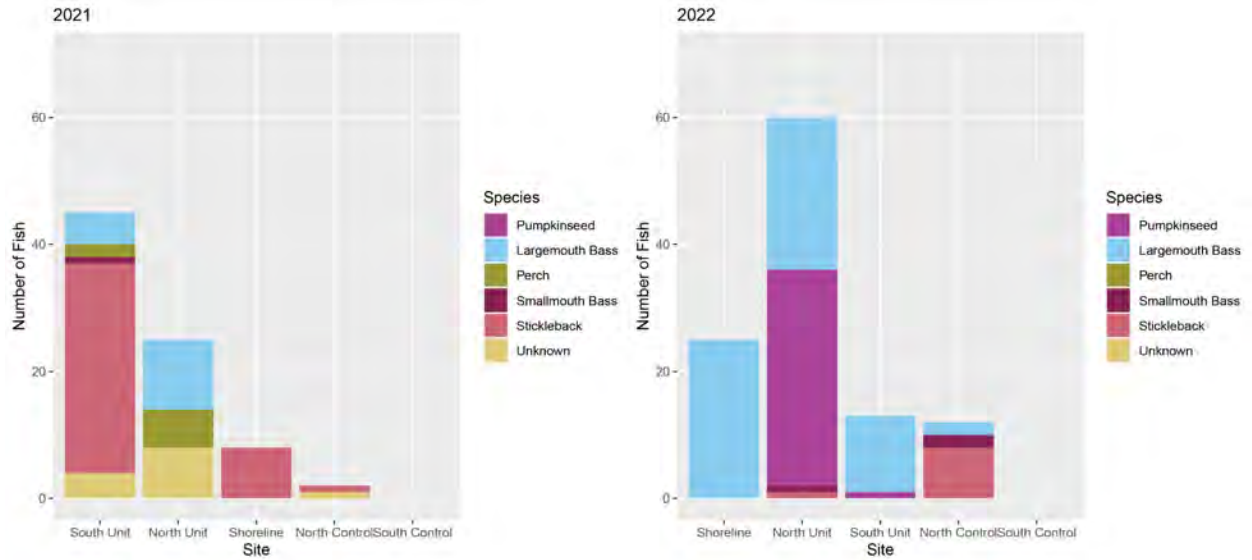
Figure 3.3.4: Total number of fish separated by species seen at each site in both study years at Fremont.

In both years of GoPro fish observation, we observed no salmonids. We identified Pumpkinseed fish, Largemouth Bass, Smallmouth Bass, Perch, and Sticklebacks. The majority of our observations consisted of Pumpkinseed fish, Largemouth Bass, and Sticklebacks. In 2021, the majority of fish sightings were recorded at the wetland units. In 2022, the majority of the sightings were still recorded at the North unit, however, the shoreline also had a significant number of sightings.

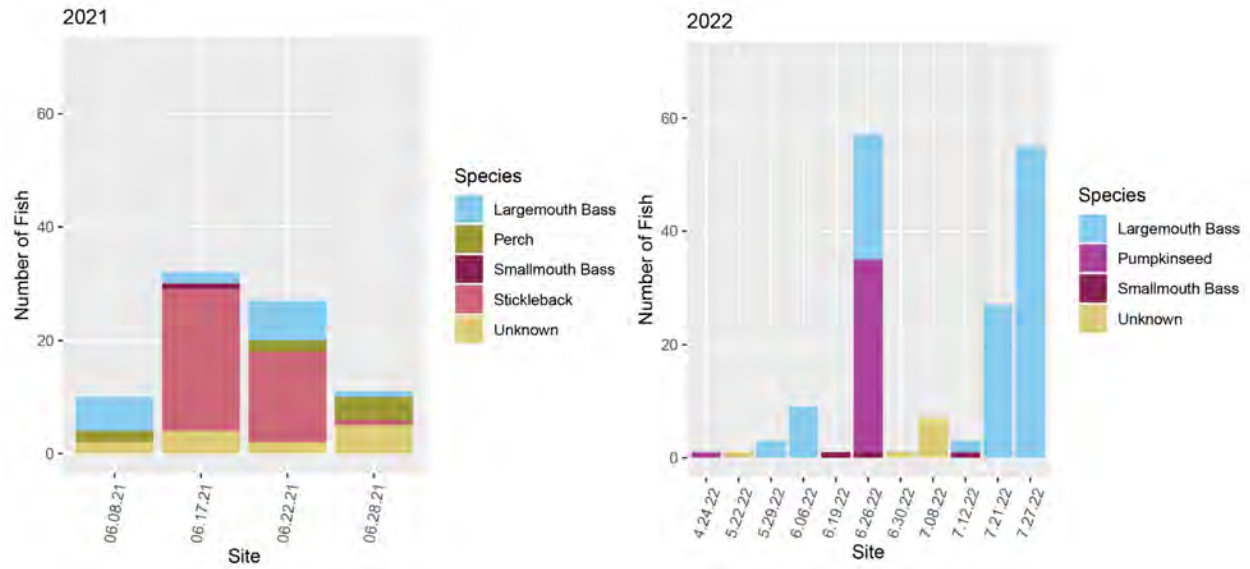
Figure 3.3.6: Figure summarizes the fish species seen over time. Each bar represents a different date in which fish data was collected.

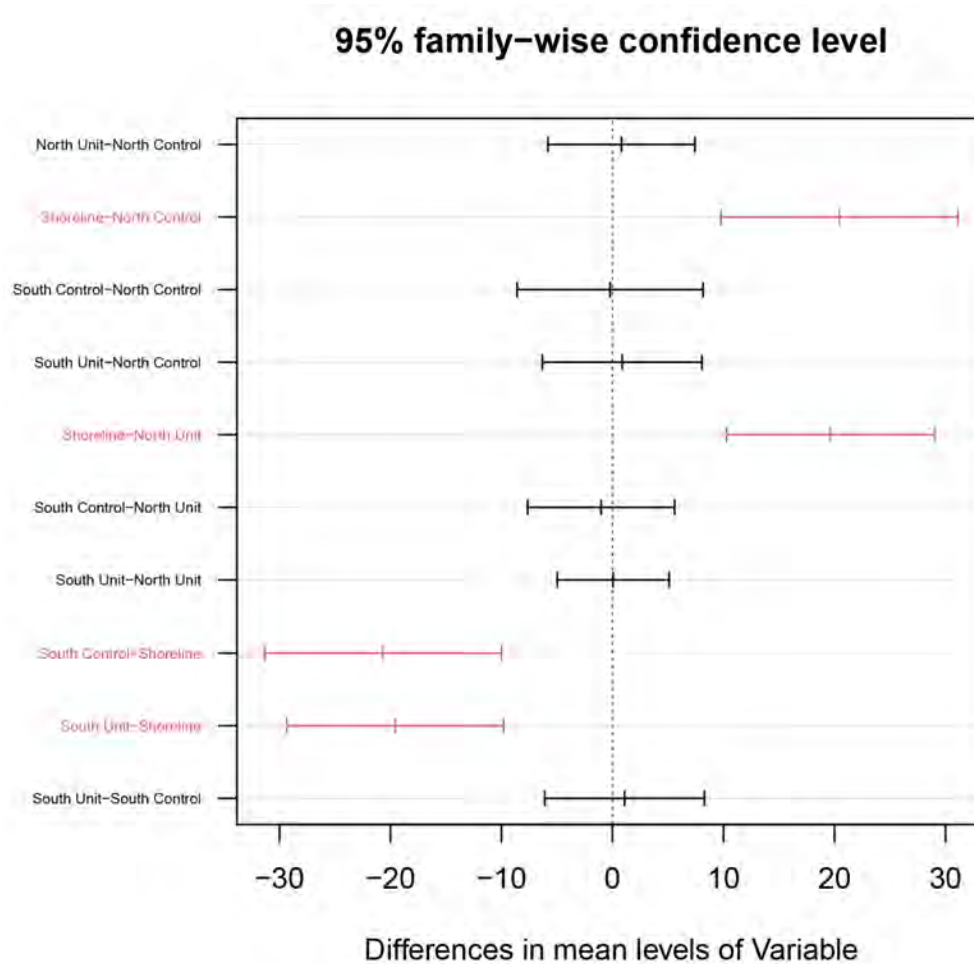
Fish	P-value
All fish species	3.85E-06
Possible Predator fish only	1.21E-15

Figure 3.3.8: Statistical analysis of fish (all species) presence between units, controls, and reference site at Fremont.

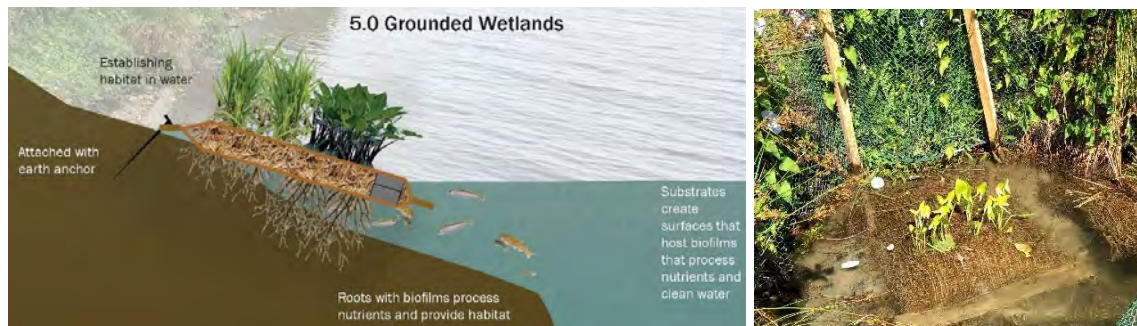
The 5.0 prototype is connected to the shoreline at one end, while the other end floats and is movable with the water level, see figure 4.1. The unit is “pillow”-like and sewn together. The unit consists of a coir fabric to hold everything together. Stuffed inside of the fabric on one side was three pumice bricks for partial flotation along with woodstraw as a substrate. The unit was then sewn together and wrapped in an additional excelsior coir blanket. The extra blanket added another level of protection if the first coir fabric ripped. The excelsior coir blanket also had grommets sewn in on the end opposite the pumice. The grommets helped attach the units to the shoreline at one end and allowed them to float with the water on the other end.

Figure 4.1: Pillow-like 5.0 wetland that moves with the water level

These units tested five different species, two in each unit, considering the water levels that they are planted in. *Scirpus microcarpus* (smallfruit bulrush), *Juncus ensifolius* (three stamened rush), *Schoenoplectus pungens/americanus* (sweetgrass), and *Sagittaria latifolia* (Wapato/broadleaf arrowhead) were alternated on the upper halves of the units. These halves would get less water than the lower halves. *Carex stipata* (awl-fruited Sedge), *Schoenoplectus pungens/americanus* (sweetgrass), and *Juncus ensifolius* (three stamened rush) were alternated on the lower half of the units.

The units were installed in the same area of SLU. Around that area of the 5.0 prototypes, wood stakes were set up and tensor was attached to them to create a barrier from geese and ducks.

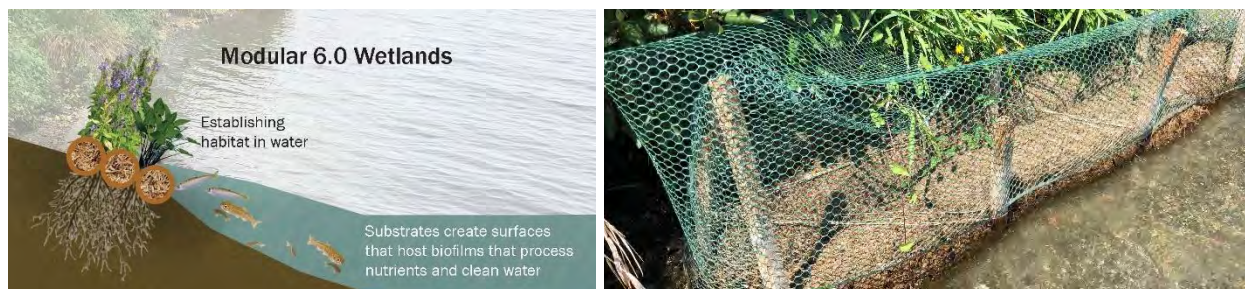
The other living shoreline prototype worked to add substrate to the existing shoreline. Three 20-foot coir logs were lined up to follow the shoreline. Coir logs, typically used for erosion control, were used for adding shoreline. They were staked into the shoreline with wood stakes to create a tight raised shoreline that is 20' x 3', see figure 4.2. One zone was placed to the south of the 5.0 prototypes and one zone was placed to the north.

Figure 4.2: Modular 6.0 wetlands made from coir logs as a living shoreline extension

The same five plants – *Scirpus microcarpus* (smallfruit bulrush), *Juncus ensifolius* (three stamened rush), *Schoenoplectus pungens/americanus* (sweetgrass), *Carex stipata* (awl-fruited Sedge), and *Sagittaria latifolia* (Wapato/broadleaf arrowhead) – were planted with the 6.0 structures. Two planting styles were tested in each zone. In one half of the zone, the plants were placed between the coir logs. In the other half, they were planted into the coir log. Tensar was added to wood stakes to keep geese and ducks off of these plants.

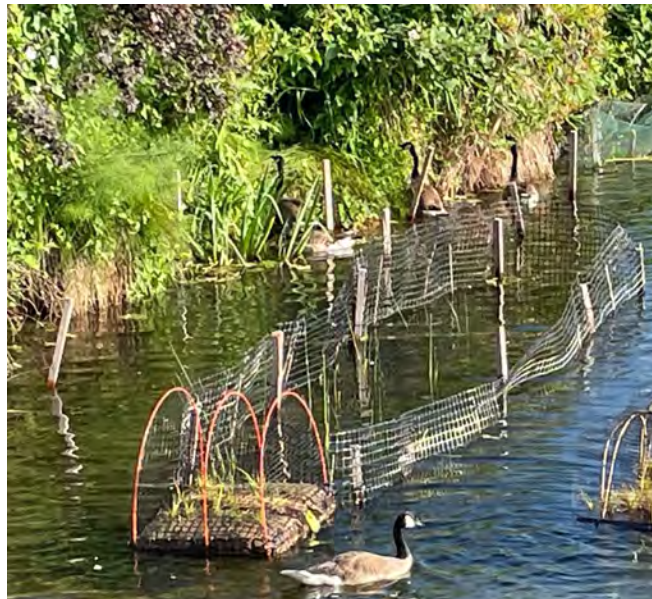
Figure 4.3: 4.0 Units growing at South Lake Union. Surrounded by new prototypes and Canada geese.

When the 4.0 units were too heavy and sinking at the Fremont bridge location, the submergent units were detached, replanted, and brought to SLU. In this water condition, they could sit at the bottom of Lake Union. 6” to 2.5’ of water remained above the units depending on the season. The plants were able to pop through the water and hold biofilms that would be beneficial for fish. The 4.0 units were clustered together, creating a new lake floor, and surrounded with deer netting to reduce geese and duck browse.

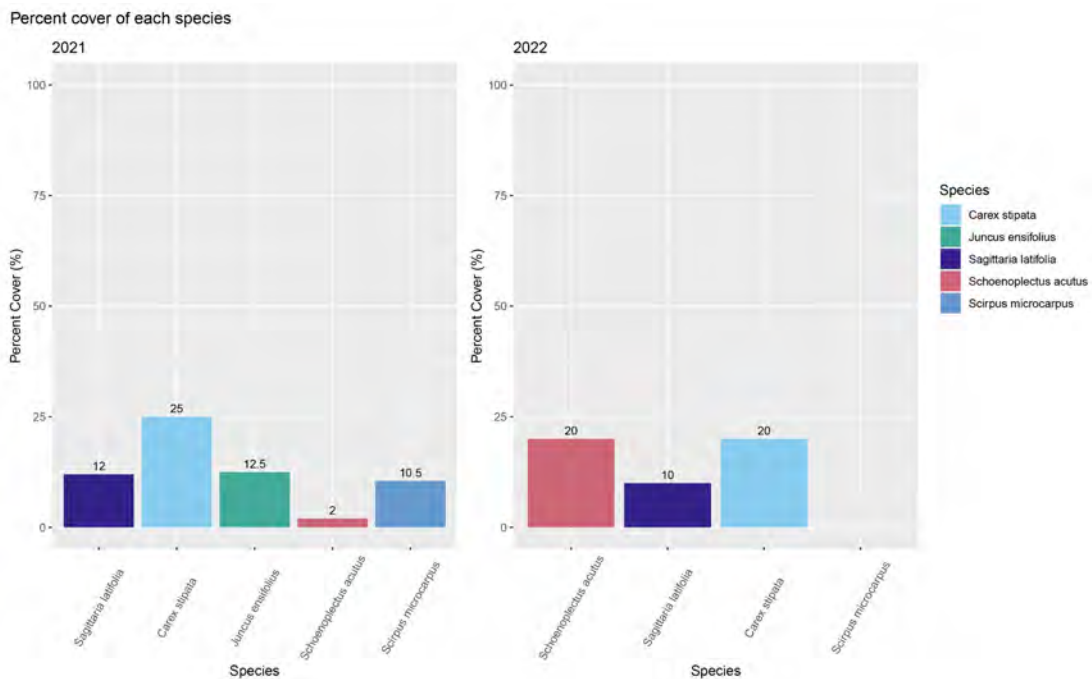
Figure 5.1.5: This figure summarizes the mean of the percent cover of each population at the end of the data collection at South Lake Union. Populations were separated by the 2021 and 2022 sample periods.

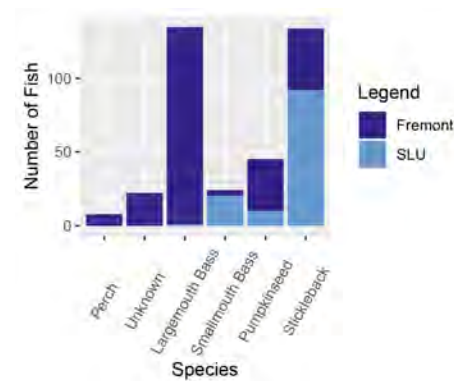
Figure 5.2.2: Figure compares the number of fish by species seen at the South Lake Union and Fremont.

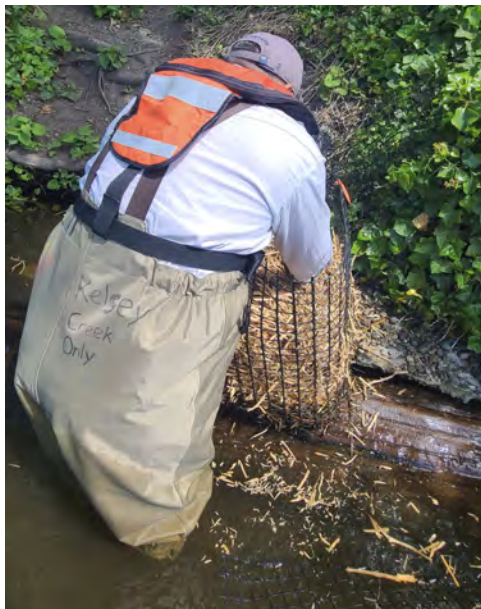
Figure 6.2: Edwin repairing floating wetlands at the Fremont location

Hernandez Rito oversaw monitoring both sites during the first year of deployment in regards to maintenance and/or repair. (Figure 6.2.)

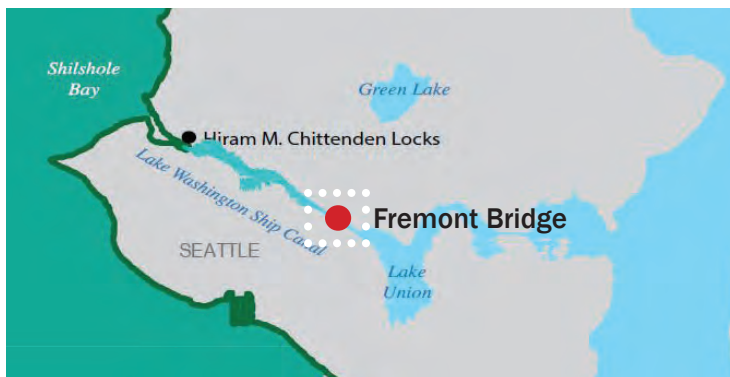
3.0/4.0 Submergent Model

Submergent plants process nutrients and provide habitat

Substrates create surfaces that host biofilms that process nutrients and clean water

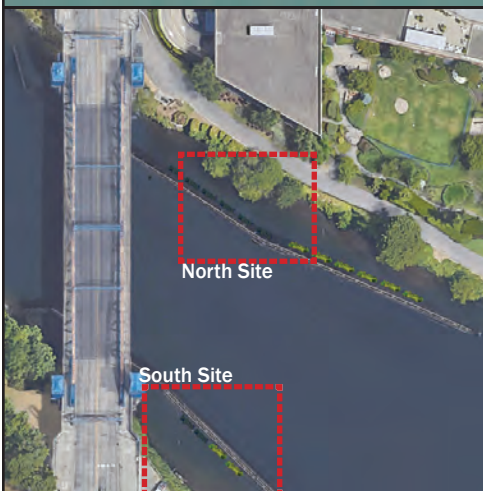
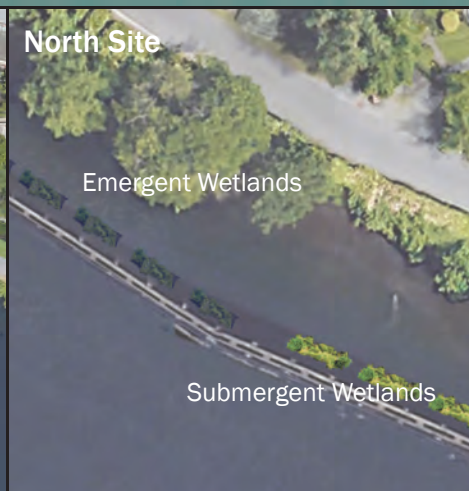
4.1 Emergent Model

South Lake Union, Seattle, WA

Testing floating and submerged living shoreline habitats in annually-fluctuating Lake Union waters.

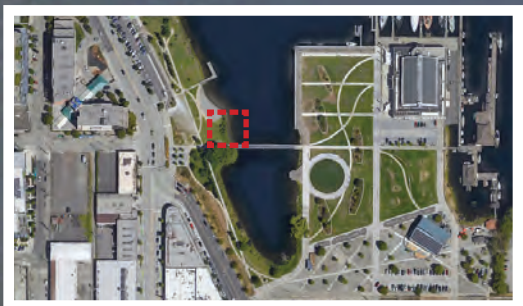
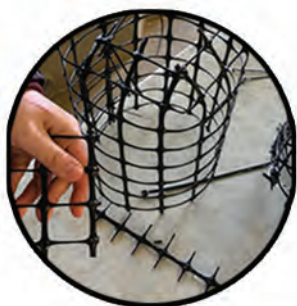
Tensar
(outer shell held together with zip ties)
